412 Dolphin St, Sunset Beach, NC 28468

PREPARED FOR: Mark Stovall
INSPECTION DATE: Wednesday, September 1, 2021
REPORT NUMBER: 090121MS2

Prepared By: Mark Stovall Home Inspections, LLC
416 Willowbrook Dr, Cary, NC 27511
(919) 254-5132
Mark@markstovall.com

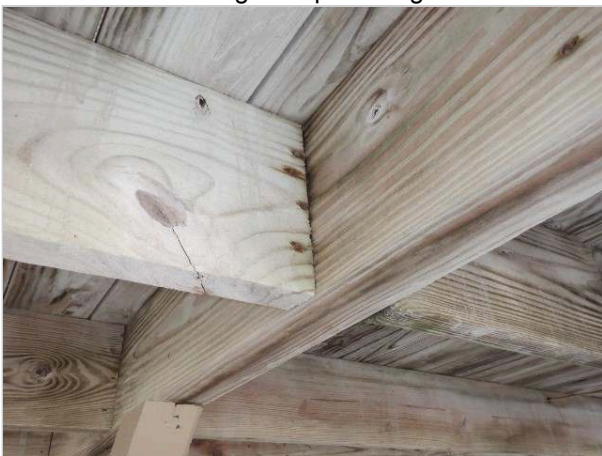
No ledger strip or hanger

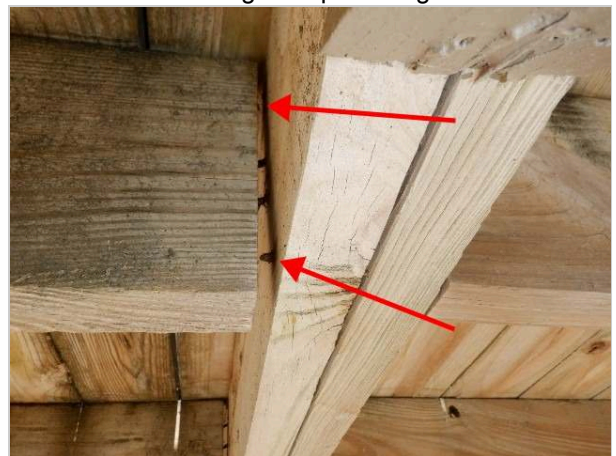
Corroded nails

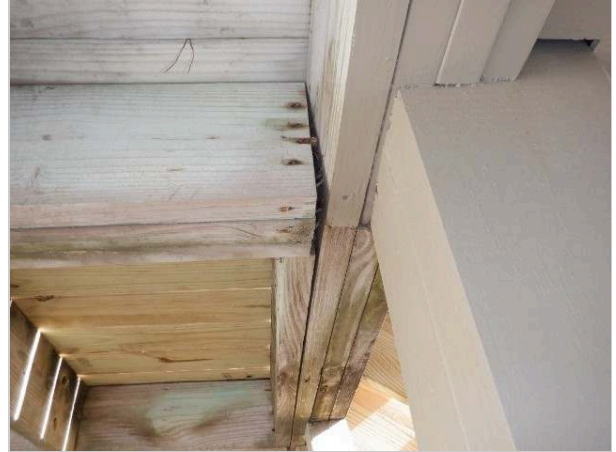
Corroded nails and separation

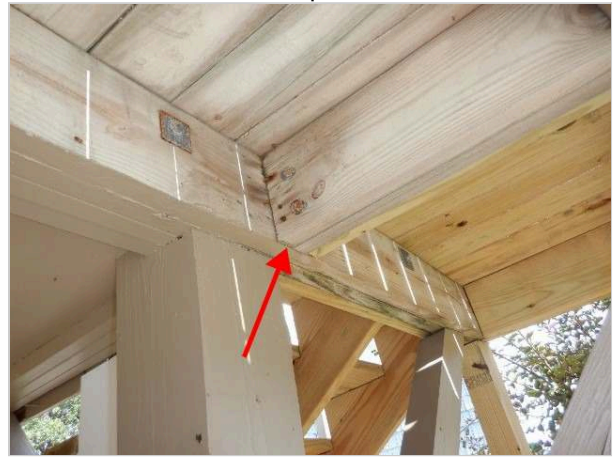
No hanger

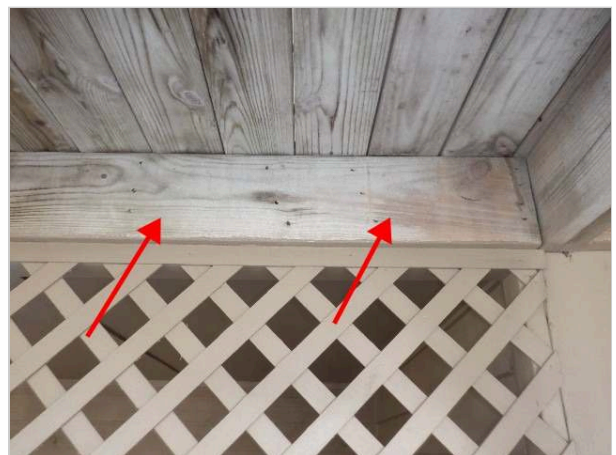
2. The lower front deck relies on a nailed attachment to the framing of the home for structural support. A supporting attachment that uses only nails presents a safety hazard due to the potential for corrosion that can jeopardize the deck support and cause the deck to collapse. When a deck is supported by attachment to the structure, specific attachment schedules utilizing a combination of hot-dipped galvanized nails and bolts or approved self-drilling screw fasteners are required to ensure stability and safety. The deck should be repaired by a licensed general contractor, if the repair is beyond the scope of the building code a licensed professional engineer should be consulted.

The lower front deck relies on a nailed attachment to the framing of the home for structural support. A supporting attachment that uses only nails presents a safety hazard due to the potential for corrosion that can jeopardize the deck support and cause the deck to collapse. When a deck is supported by attachment to the structure, specific attachment schedules utilizing a combination of hot-dipped galvanized nails and bolts or approved self-drilling screw fasteners are required to ensure stability and safety. The deck should be repaired by a licensed general contractor, if the repair is beyond the scope of the building code a licensed professional engineer should be consulted.

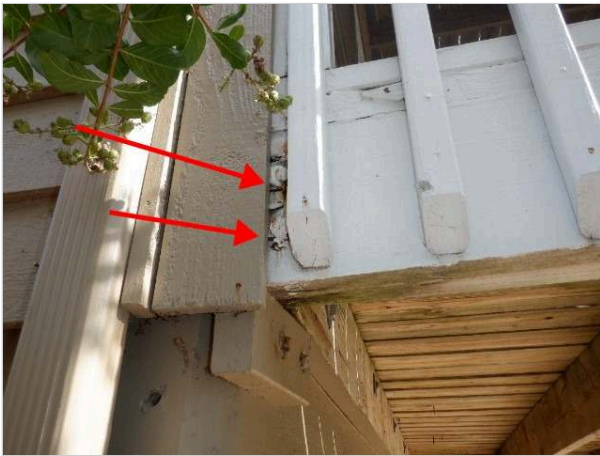
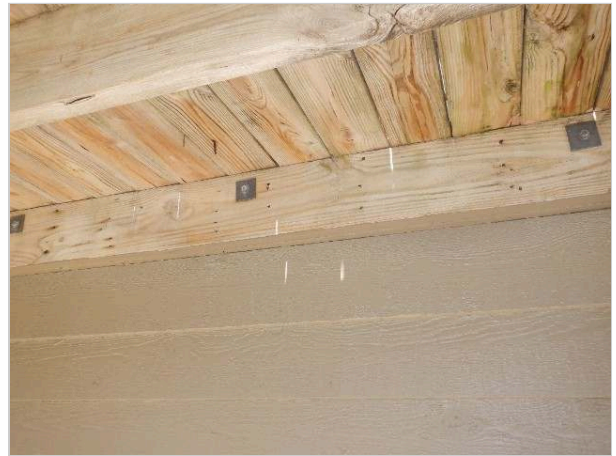
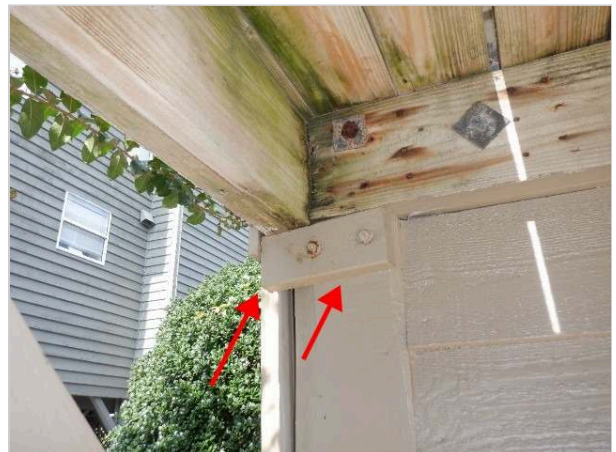
3. The lower rear deck appears to rely on a lag bolt attachment to the framing of the home for structural support. A supporting attachment that uses only lag bolts presents a safety hazard due to the potential for corrosion that can jeopardize the deck support and cause the deck to collapse. When a deck is supported by attachment to the structure, specific attachment schedules utilizing a combination of hot-dipped galvanized nails and bolts or approved self-drilling screw fasteners are required to ensure stability and safety. Steps have been taken on the rear deck, in the form of lagged blocking, to arrest sagging with debatable results. The deck should be repaired by a licensed general contractor, if the repair is beyond the scope of the building code a licensed professional engineer should be consulted.

The lower rear deck appears to rely on a lag bolt attachment to the framing of the home for structural support. A supporting attachment that uses only lag bolts presents a safety hazard due to the potential for corrosion that can jeopardize the deck support and cause the deck to collapse. When a deck is supported by attachment to the structure, specific attachment schedules utilizing a combination of hot-dipped galvanized nails and bolts or approved self-drilling screw fasteners are required to ensure stability and safety. Steps have been taken on the rear deck, in the form of lagged blocking, to arrest sagging with debatable results. The deck should be repaired by a licensed general contractor, if the repair is beyond the scope of the building code a licensed professional engineer should be consulted.

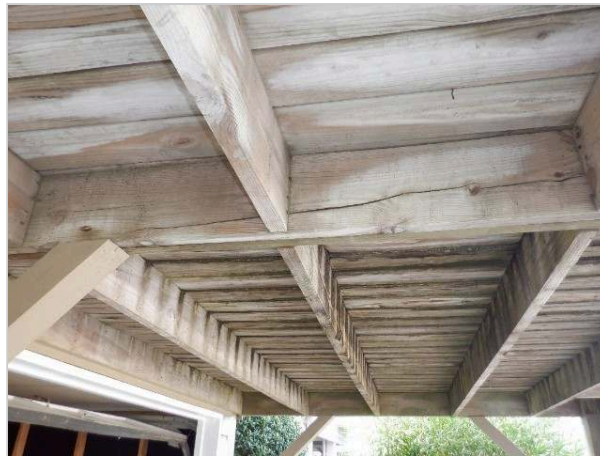
4. At the lower front deck, one of the girder framing members is split. This could allow for further structural movement of the deck and possible failure. The deck should be repaired by a licensed general contractor, if the repair is beyond the scope of the building code a licensed professional engineer should be consulted.

At the lower front deck, one of the girder framing members is split. This could allow for further structural movement of the deck and possible failure. The deck should be repaired by a licensed general contractor, if the repair is beyond the scope of the building code a licensed professional engineer should be consulted.

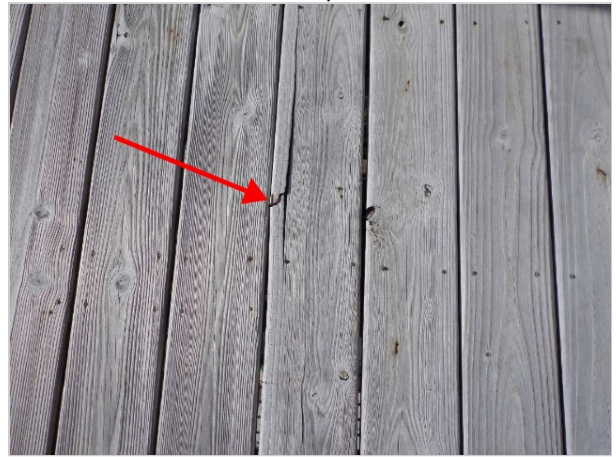
Example

5. On multiple areas of the decks and steps, there are several water damaged boards. These boards will continue to deteriorate and eventually become unsafe. Have a qualified contractor repair as required.

On multiple areas of the decks and steps, there are several water damaged boards. These boards will continue to deteriorate and eventually become unsafe. Have a qualified contractor repair as required.

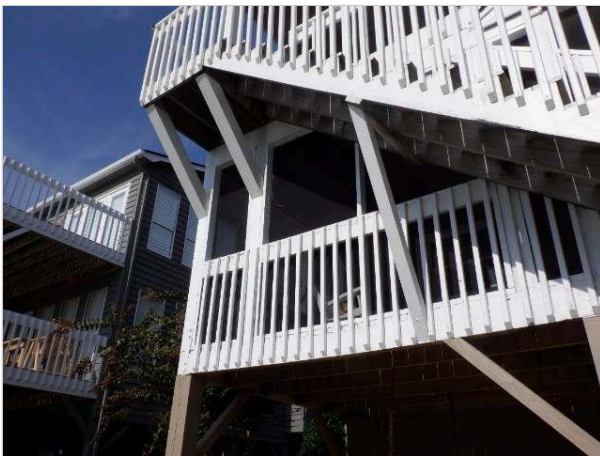
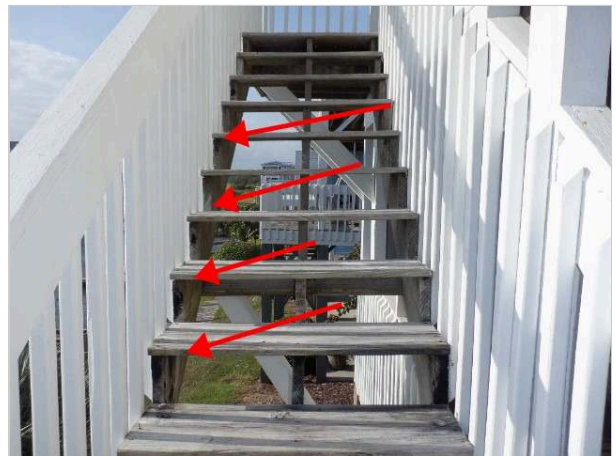
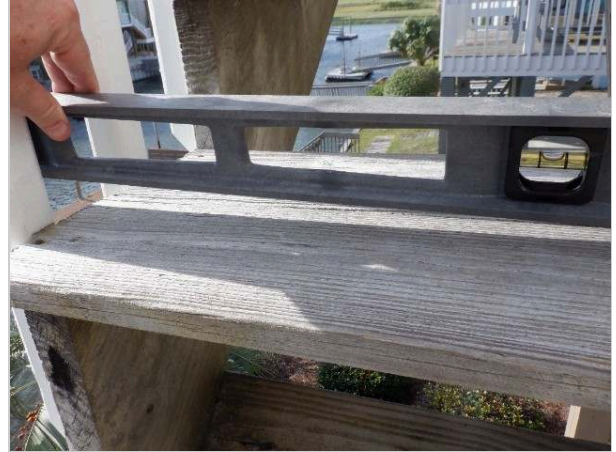
6. The rear cantilevered steps to the rear middle deck are in poor condition. The stair system is sagging away from the home. Across the width of the steps, the stair system is sagging approximately 2 1/2 inches. If left, this condition will continue to deteriorate and the steps may fail and collapse.

The rear cantilevered steps to the rear middle deck are in poor condition. The stair system is sagging away from the home. Across the width of the steps, the stair system is sagging approximately 2 1/2 inches. If left, this condition will continue to deteriorate and the steps may fail and collapse.

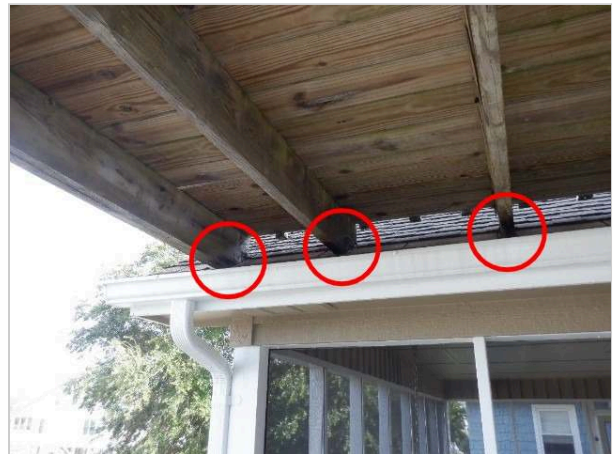
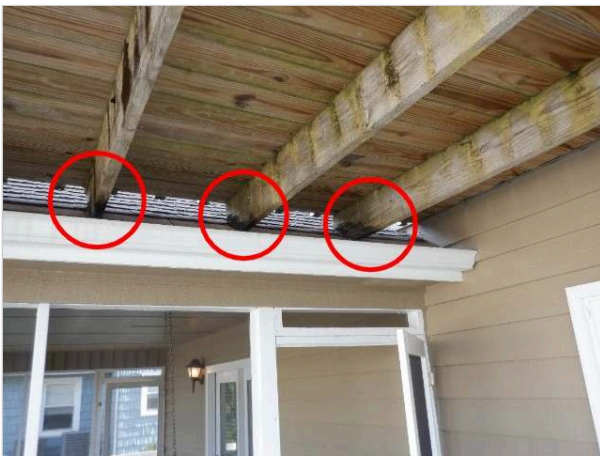
7. The front upper deck has floor joists that appear to sit directly on top of the lower roof system. These joists do not appear to be attached to the roofing system. Further, as the joists are sitting on the roof shingles, this damages both the shingles and keeps the deck joists wet to the point of deterioration. These conditions could allow for roof leaks and deterioration of the deck joists to the point of structural movement and need of replacement. Have a qualified contractor repair this condition as necessary.

The front upper deck has floor joists that appear to sit directly on top of the lower roof system. These joists do not appear to be attached to the roofing system. Further, as the joists are sitting on the roof shingles, this damages both the shingles and keeps the deck joists wet to the point of deterioration. These conditions could allow for roof leaks and deterioration of the deck joists to the point of structural movement and need of replacement. Have a qualified contractor repair this condition as necessary.

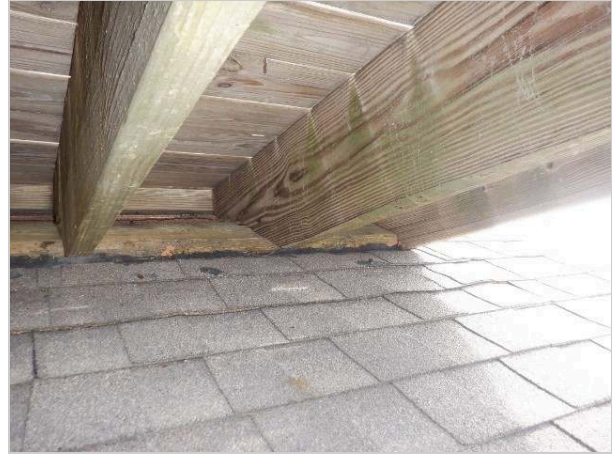
8. The rear top deck stairs are supported by wood members sitting directly on top of the roof shingles. This condition appears to prevent the roof from draining properly in this area and holds water against the supporting wood member. These conditions could allow for roof leaks and deterioration of the deck support to the point of structural movement and need of replacement. Have a qualified contractor repair this condition as necessary.

The rear top deck stairs are supported by wood members sitting directly on top of the roof shingles. This condition appears to prevent the roof from draining properly in this area and holds water against the supporting wood member. These conditions could allow for roof leaks and deterioration of the deck support to

the point of structural movement and need of replacement. Have a qualified contractor repair this condition as necessary.

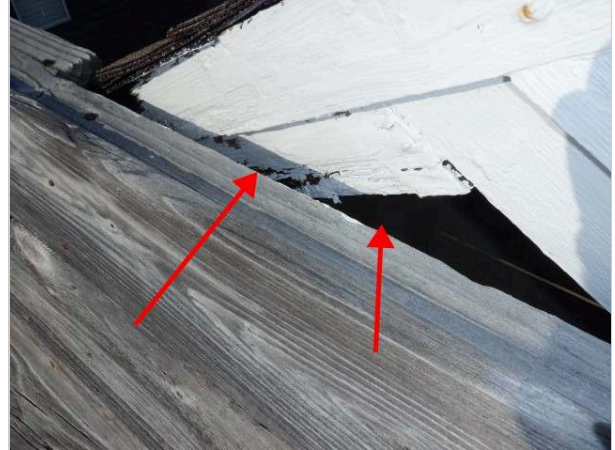
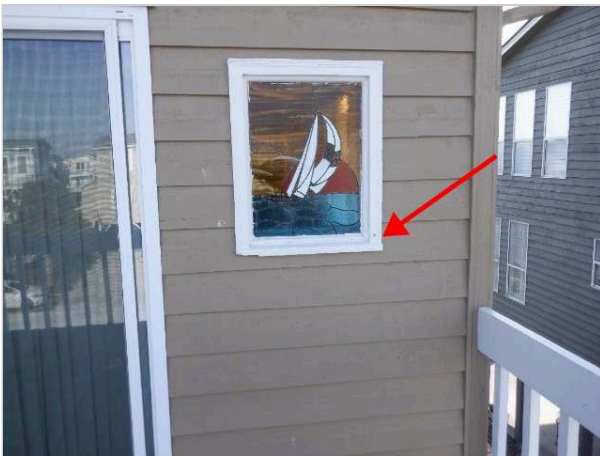
1. The exterior trim is water damaged in three places (these areas include, but are not limited to areas seen in photos). This is at the right side of the garage door, and at the rear gable end of the roof and at the stain glass window. If left, this will deteriorate further, attract mold and wood destroying organisms and allow moisture to penetrate structural components. Have a qualified contractor evaluate and advise regarding siding, trim, and any affected structural components, then repair as required.

The exterior trim is water damaged in three places (these areas include, but are not limited to areas seen in photos). This is at the right side of the garage door, and at the rear gable end of the roof and at the stain glass window. If left, this will deteriorate further, attract mold and wood destroying organisms and allow moisture to penetrate structural components. Have a qualified contractor evaluate and advise regarding siding, trim, and any affected structural components, then repair as required.

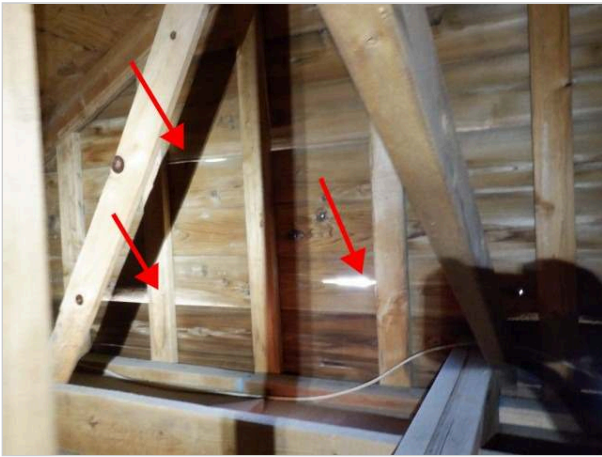
Daylight at front gable

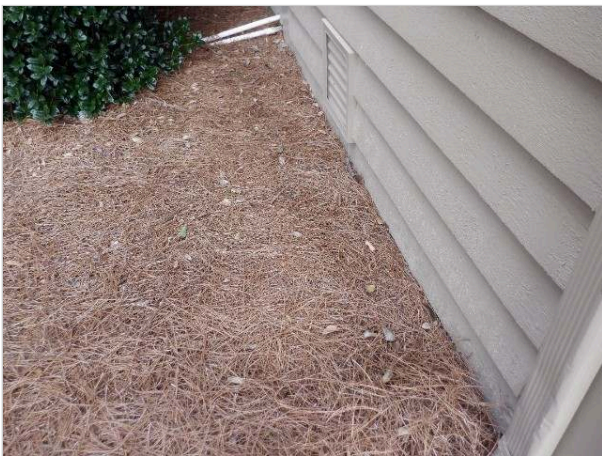
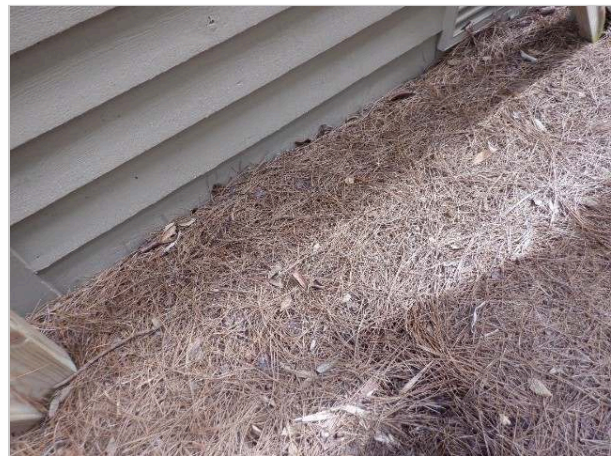
4. At the the right side of the home, the ground cover is against the trim and lower siding. This condition will cause the wood components to rot and creates an environment attractive to wood destroying insects and fungi. Have a qualified contractor re-work the landscaping to alleviate this condition.

At the the right side of the home, the ground cover is against the trim and lower siding. This condition will cause the wood components to rot and creates an environment attractive to wood destroying insects and fungi. Have a qualified contractor re-work the landscaping to alleviate this condition.

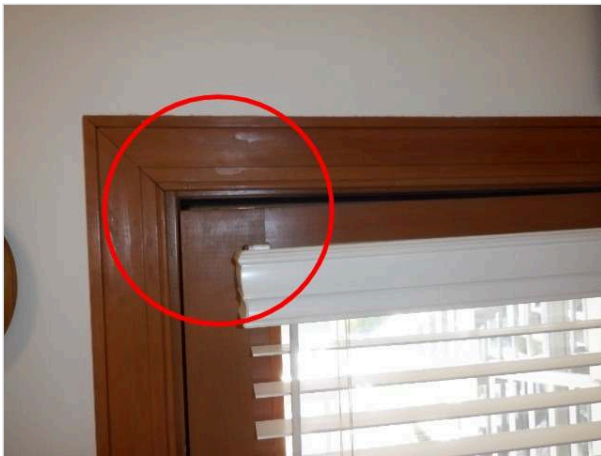
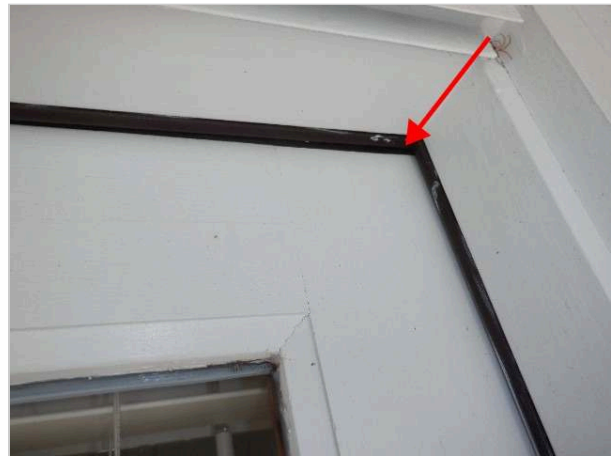
2. At the rear door, daylight can be seen through the weather stripping. This will waste energy and allow pests access to the home. Have a qualified contractor repair as required.

At the rear door, daylight can be seen through the weather stripping. This will waste energy and allow pests access to the home. Have a qualified contractor repair as required.

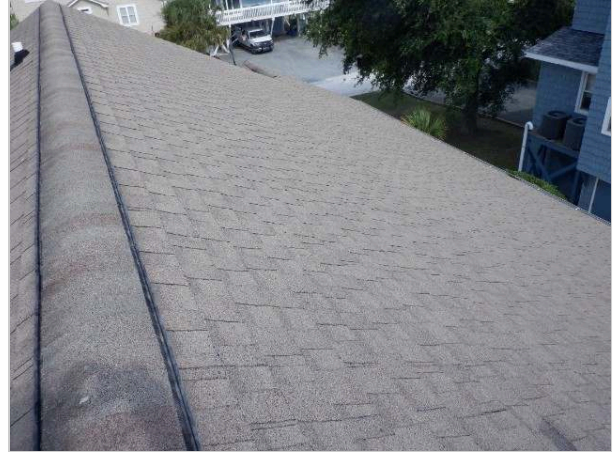
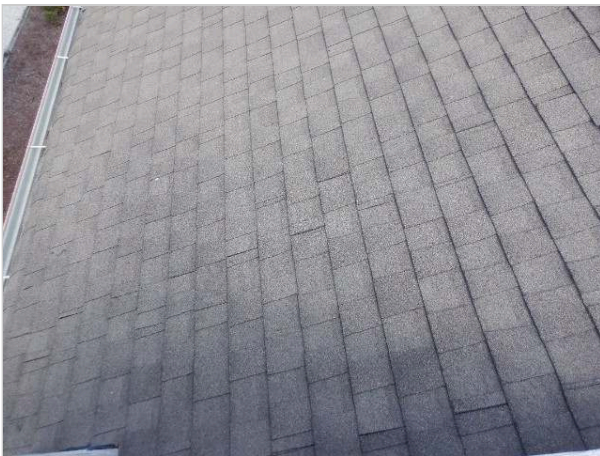
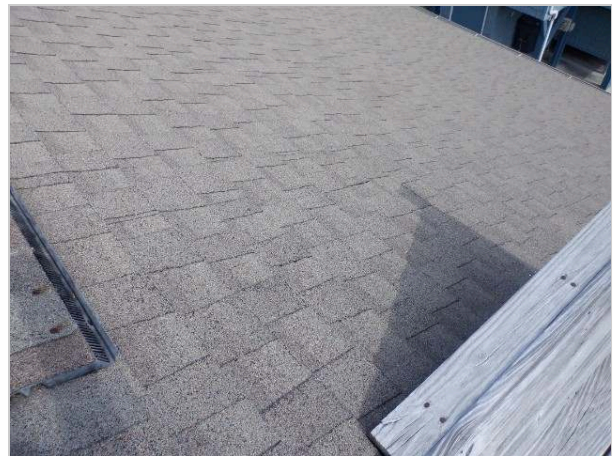
1. This roof appears to be nearing its useful, reliable lifespan. All of the shingles exhibit wear to the extent of showing the fiberglass substrate at the edges and considerable granule loss. If left, water damage can occur to structural components. Have a qualified contractor to evaluate, advise, and replace.

This roof appears to be nearing its useful, reliable lifespan. All of the shingles exhibit wear to the extent of showing the fiberglass substrate at the edges and considerable granule loss. If left, water damage can occur to structural components. Have a qualified contractor to evaluate, advise, and replace.

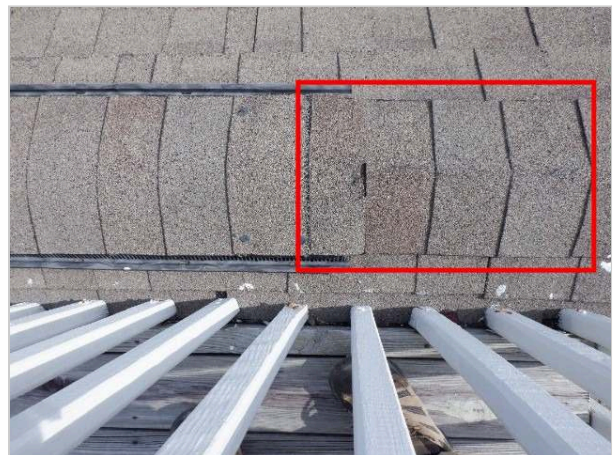
2. On the peak of the roof, there are several shingles that are cracked or broken. If not repaired, these may allow rain water to blow under the shingles and are more likely to become wind damaged. Have a qualified contractor repair as required.

On the peak of the roof, there are several shingles that are cracked or broken. If not repaired, these may allow rain water to blow under the shingles and are more likely to become wind damaged. Have a qualified contractor repair as required.

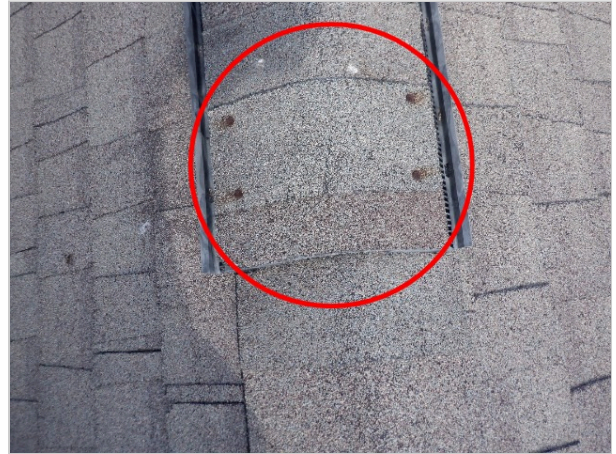
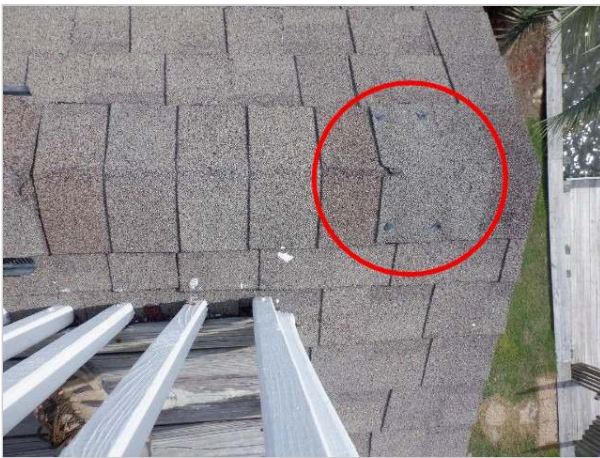
3. There are nail heads exposed on the shingles at the ridge vent. This can allow moisture to penetrate around the nail heads and damage the roof sheathing. Have a qualified roofing contractor seal the nails as required.

There are nail heads exposed on the shingles at the ridge vent. This can allow moisture to penetrate around the nail heads and damage the roof sheathing. Have a qualified roofing contractor seal the nails as required.

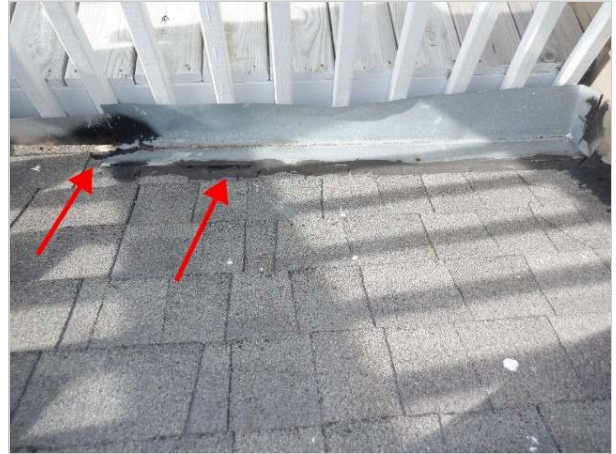
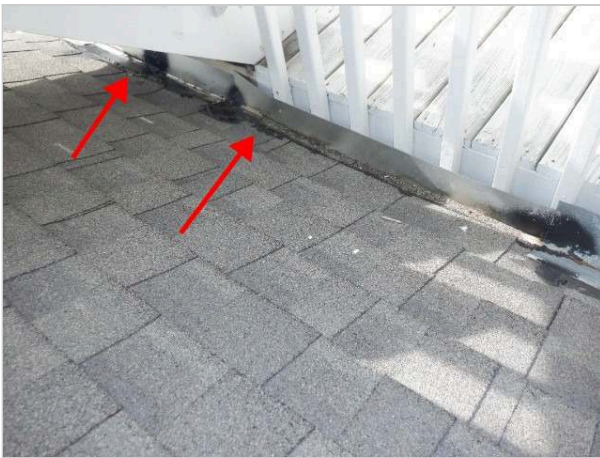
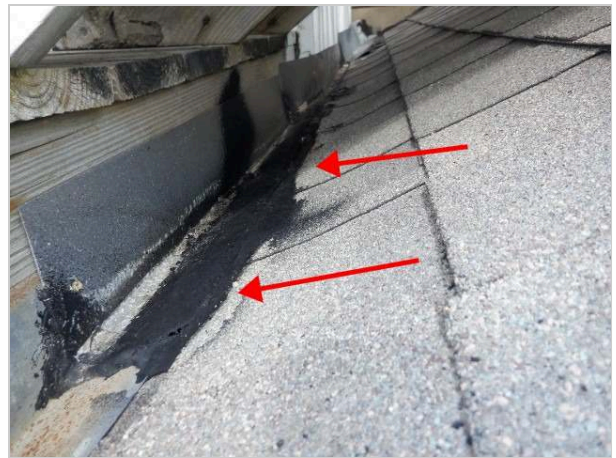
5. The flashing on the roof adjacent to the rear mid-level deck is not properly installed and is pulling away from the singles and sealant. This can allow wind-blown rain to penetrate damaging interior and structural components. Have a qualified contractor repair the flashing.

The flashing on the roof adjacent to the rear mid-level deck is not properly installed and is pulling away from the shingles and sealant. This can allow wind-blown rain to penetrate damaging interior and structural components. Have a qualified contractor repair the flashing.

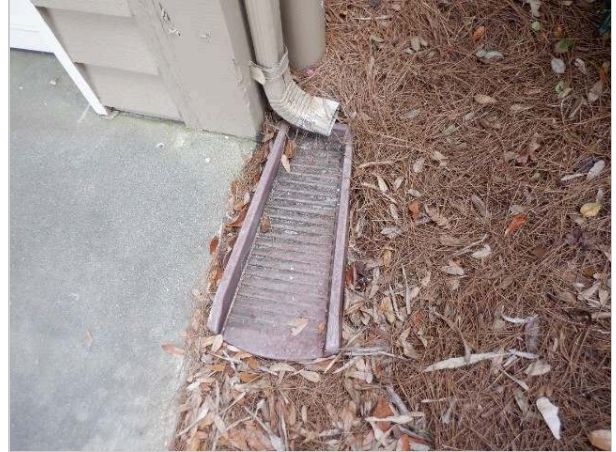
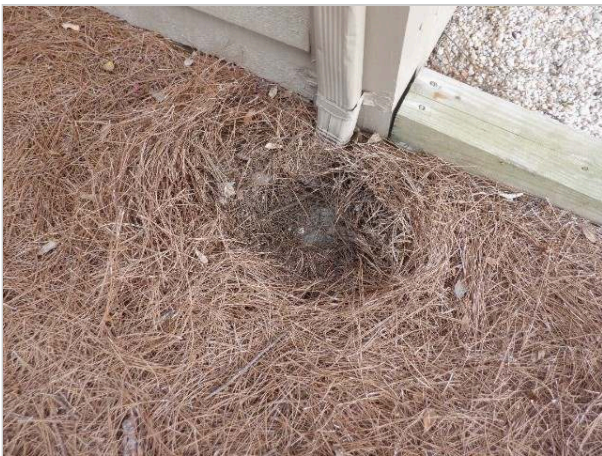
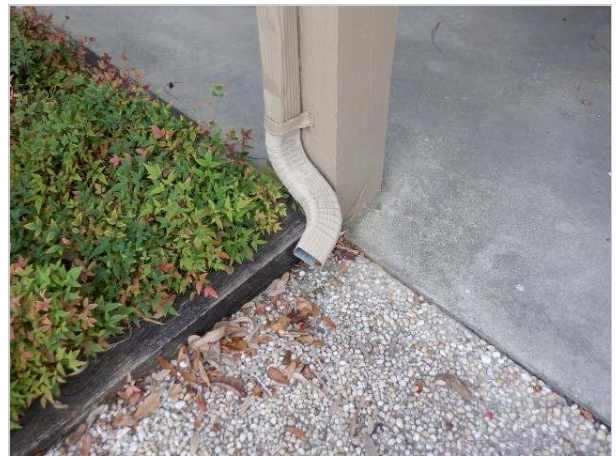
1. There were four downspouts draining at or too close to the foundation. If not moved away from the structure properly, this water can adversely affect the foundation and wood pilings. Have a qualified contractor correct this condition as required.

There were four downspouts draining at or too close to the foundation. If not moved away from the structure properly, this water can adversely affect the foundation and wood pilings. Have a qualified contractor correct this condition as required.

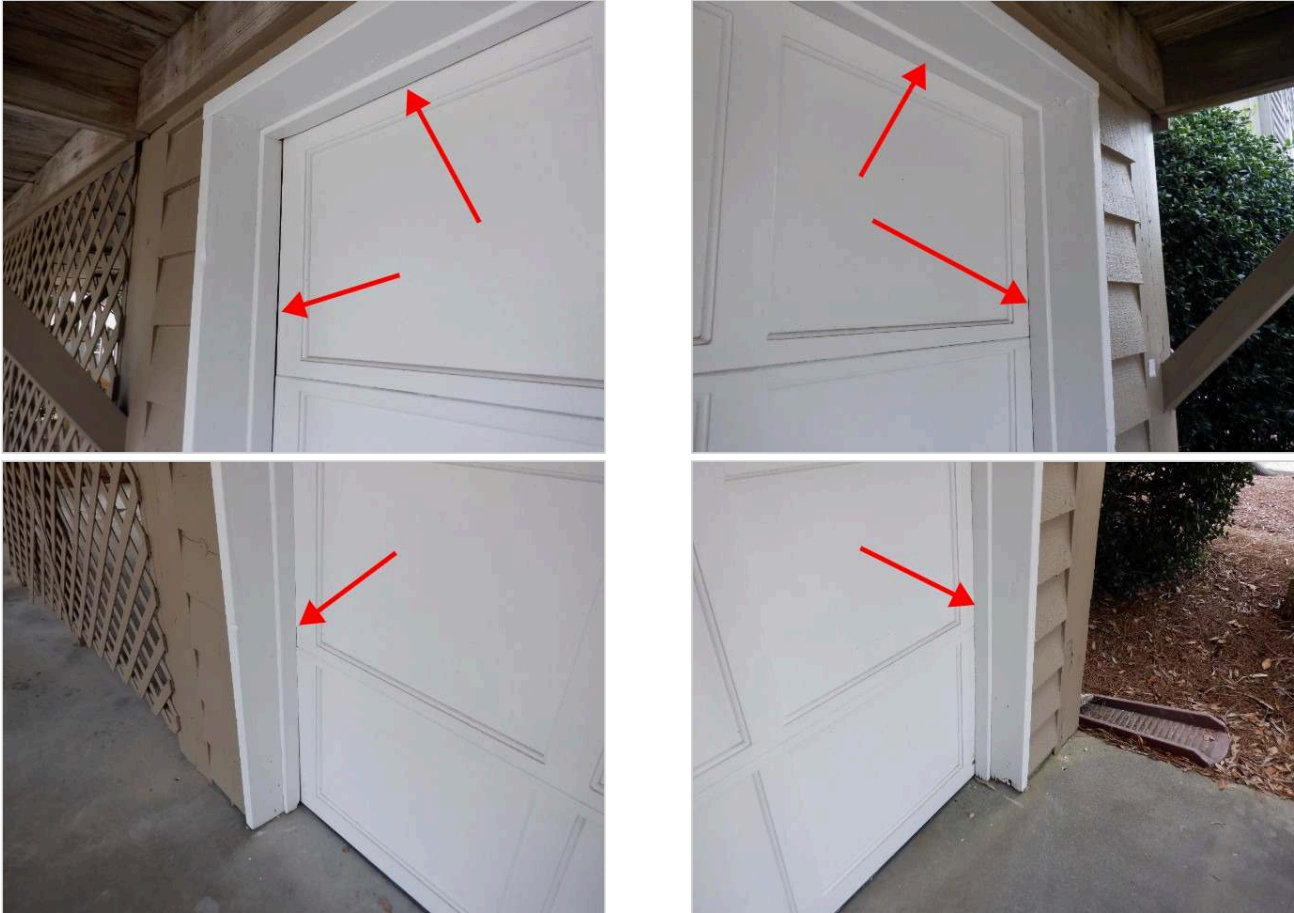
1. At the garage roll-up door(s), there is missing weather stripping. This could allow rain to blow into the garage or provide access for pests. Have a qualified contractor install weather stripping on this door.

At the garage roll-up door(s), there is missing weather stripping. This could allow rain to blow into the garage

or provide access for pests. Have a qualified contractor install weather stripping on this door.

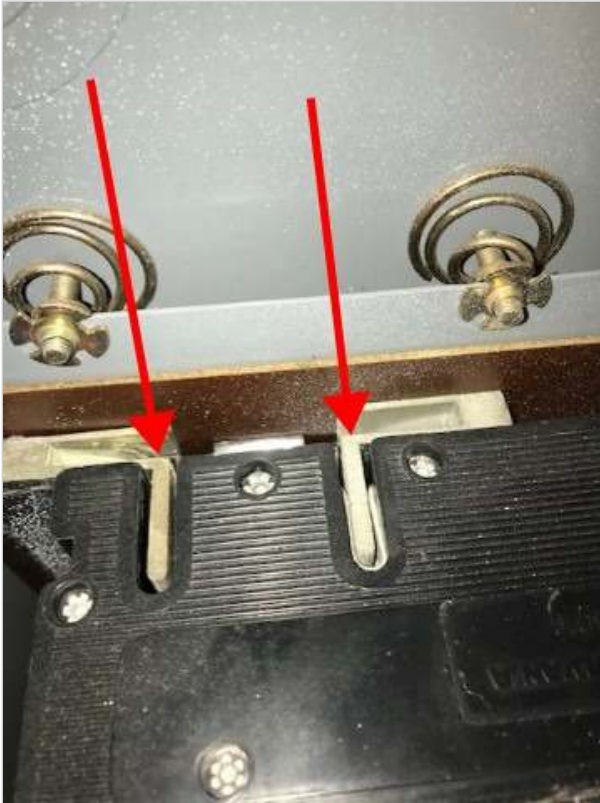
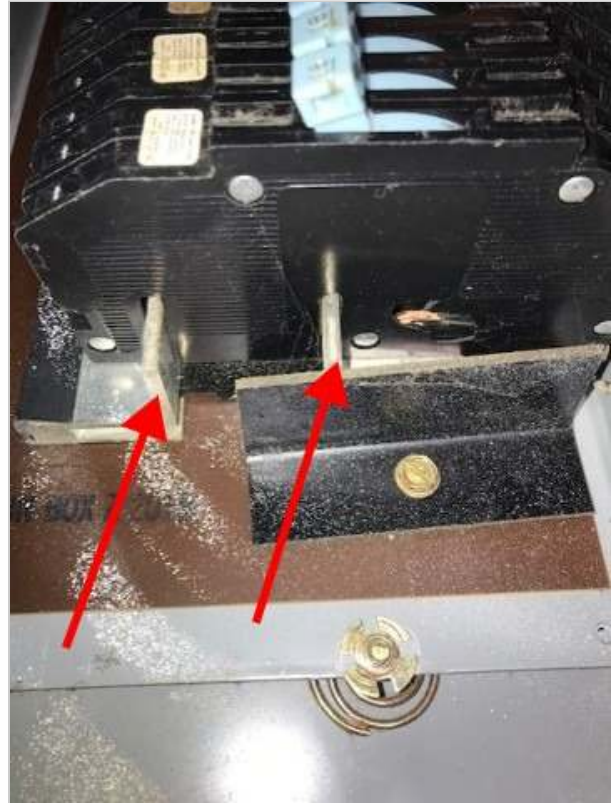
1. The electrical system of this home contains a what appears to be a re-branded Zinsco service panel and or a service panel with Zinsco components. Although Zinsco panels and components were innovative at the time of inception, the reliability and safety of the panel has been in question due to documented circuit breaker and busbar failures. These panels have been associated with overheating, failure to trip, fires, and other defects. A licensed electrical contractor should be consulted for a complete invasive inspection of the electrical panel to determine if repair, modification, or replacement is needed to ensure safe and reliable service.

The electrical system of this home contains a what appears to be a re-branded Zinsco service panel and or a service panel with Zinsco components. Although Zinsco panels and components were innovative at the time of inception, the reliability and safety of the panel has been in question due to documented circuit breaker and busbar failures. These panels have been associated with overheating, failure to trip, fires, and other defects. A licensed electrical contractor should be consulted for a complete invasive inspection of the electrical panel to determine if repair, modification, or replacement is needed to ensure safe and reliable service.

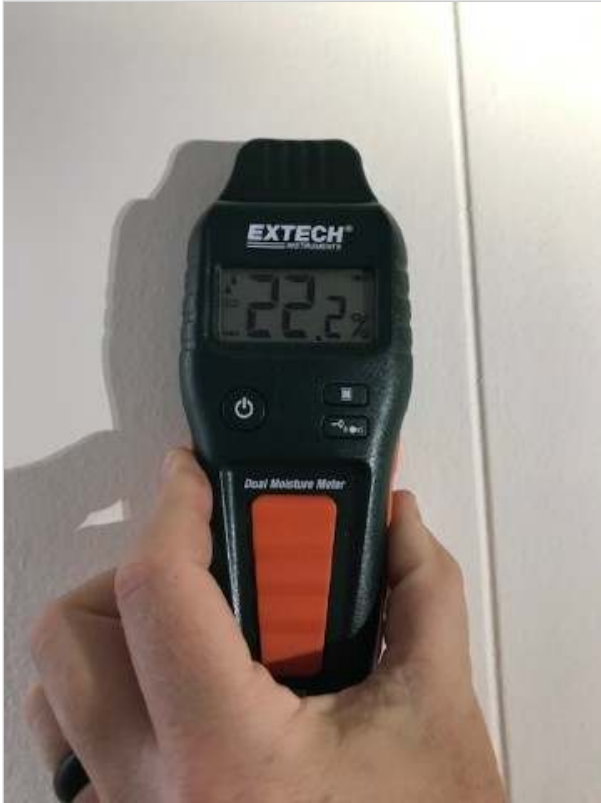
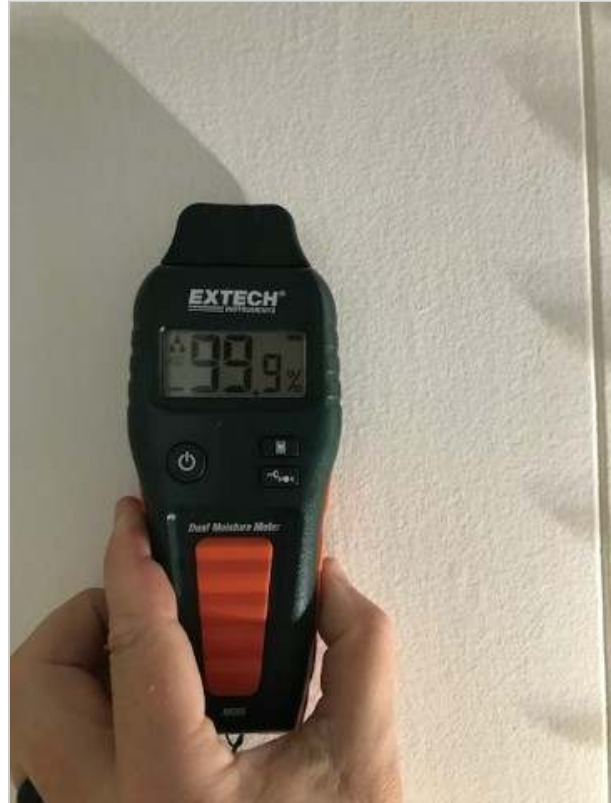
On the downstairs front bedroom wall, damage to the wall paneling and evidence of repainting indicates repairs in this area. The normal wall moisture level is approximately 10% in this home. The right side of the rear window shows 22% moisture content, while the left side of the window shows a 99% measurement. This suggests that the framing or insulation behind the paneling is wet. This could allow for rot and damage to the framing components and is attractive to wood destroying organisms. Have a qualified contractor repair this condition as necessary.

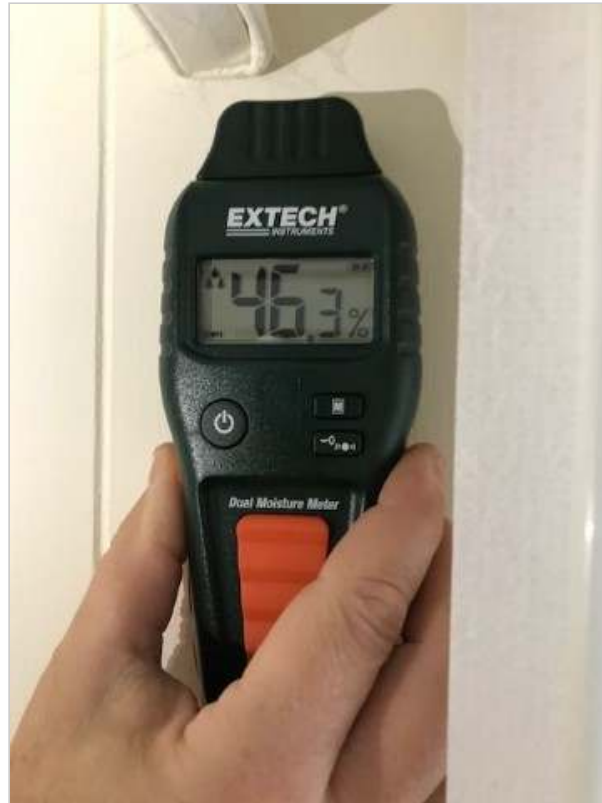
2. On the upstairs rear bedroom wall, on the left side of the sliding glass door, measurements of the moisture content levels reflect 46%. The normal wall moisture level is approximately 10% in this home. This suggests that the framing or insulation behind the paneling is wet. This could allow for rot and damage to the framing components and is attractive to wood destroying organisms. Have a qualified contractor repair this condition as necessary.

On the upstairs rear bedroom wall, on the left side of the sliding glass door, measurements of the moisture content levels reflect 46%. The normal wall moisture level is approximately 10% in this home. This suggests that the framing or insulation behind the paneling is wet. This could allow for rot and damage to the framing components and is attractive to wood destroying organisms. Have a qualified contractor repair this condition as necessary.

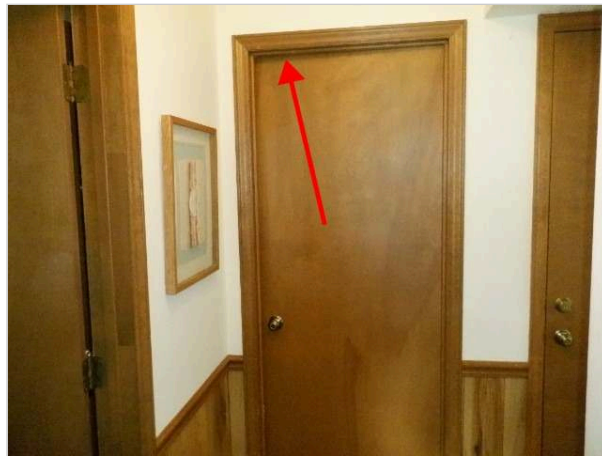
5. At the downstairs rear bedroom door, the door bumps and rubs on the frame. This will accelerate wear on the door, frame, and hardware. Have a qualified contractor evaluate, and repair as required.

At the downstairs rear bedroom door, the door bumps and rubs on the frame. This will accelerate wear on the door, frame, and hardware. Have a qualified contractor evaluate, and repair as required.

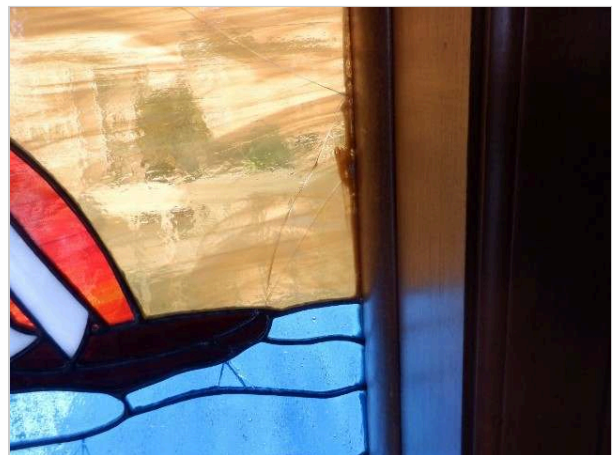
6. Cracked glass was noted on the stained glass window. For safety and security all cracked and broken glass should be replaced. Have a qualified contractor repair or replace the window as required.

Cracked glass was noted on the stained glass window. For safety and security all cracked and broken glass should be replaced. Have a qualified contractor repair or replace the window as required.

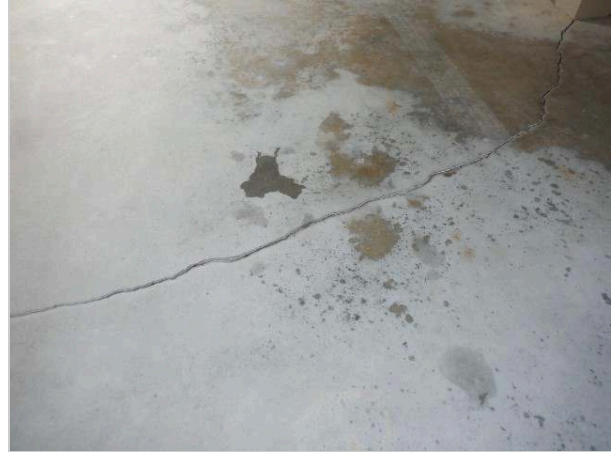
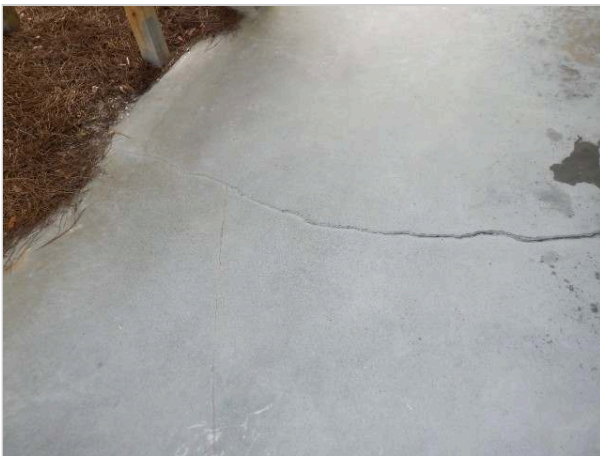
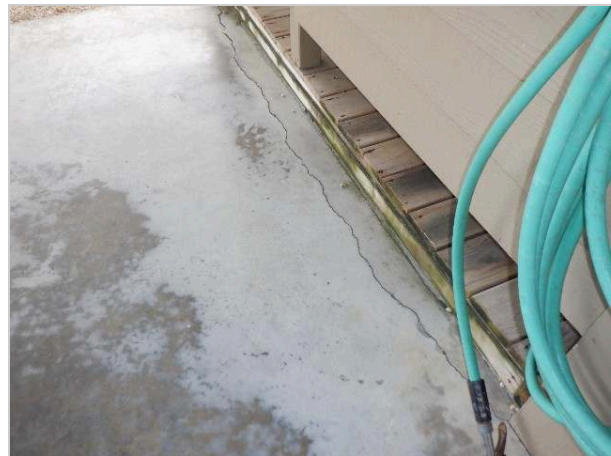
1. The parking pad/ slab has cracked and settled unevenly. These conditions may deteriorate further especially in freezing conditions, in the presence of moisture, and can be a tripping hazard. Have a qualified contractor evaluate and repair as required.

The parking pad/ slab has cracked and settled unevenly. These conditions may deteriorate further especially in freezing conditions, in the presence of moisture, and can be a tripping hazard. Have a qualified contractor evaluate and repair as required.

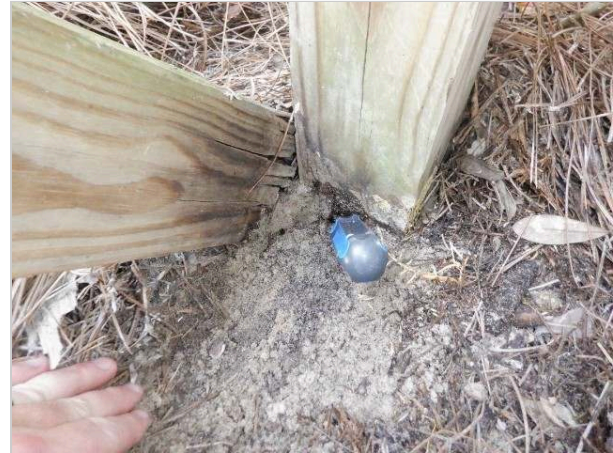
On the right side of the home, at the HVAC unit(s) platform, the platform posts are rotted at ground level. This has affected the platform's structural integrity and the assembly is rocking from side to side - in danger of collapse. Have a qualified contractor repair this platform as necessary.

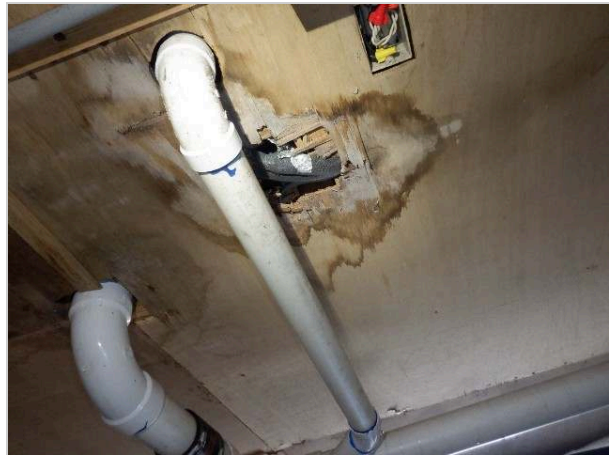
In the garage area, the ceiling is water stained and damaged due, apparently, to the condensation forming on the HVAC line sets that pass through the garage ceiling. If left, this can continue to deteriorate structural components of the ceiling/floor system. Have a qualified HVAC contractor repair this condition as necessary. Have a qualified contractor repair any structural components as necessary.

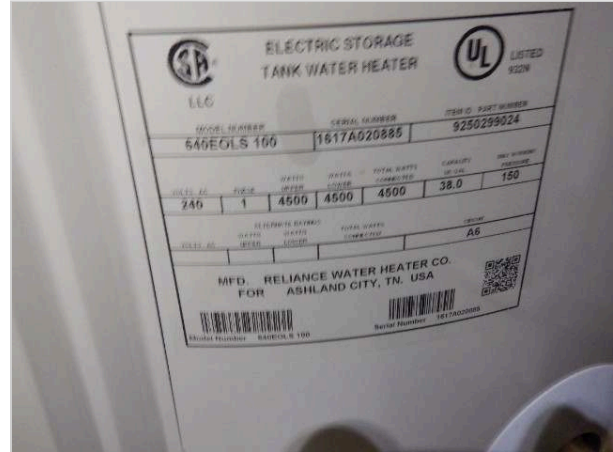
This water heater is sitting directly on the floor with no drip pan. In the event of minor leaks a drip pan can protect floors and other structural components and finishes. Recommend having a qualified plumbing contractor install a drip pan here.
