412 Dolphin St, Sunset Beach, NC 28468

PREPARED FOR: Mark Stovall
INSPECTION DATE: Wednesday, September 1, 2021
REPORT NUMBER: 090121MS2

Prepared By: Mark Stovall Home Inspections, LLC
416 Willowbrook Dr, Cary, NC 27511
(919) 254-5132
Mark@markstovall.com

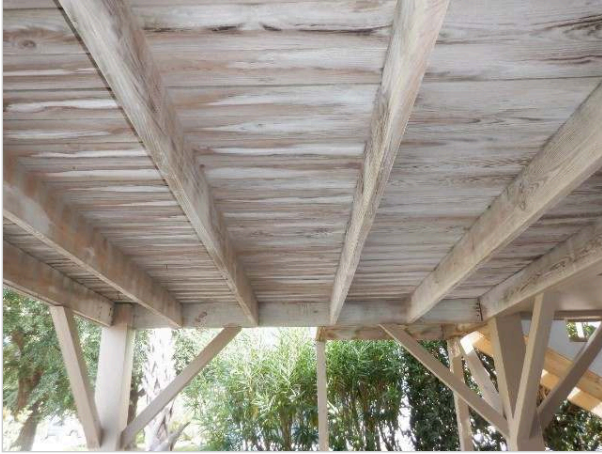
The structural integrity of the lower front and rear decks is poor. The decks were constructed with floor joists framed at 24" on center with no joist ledger strip or joist hangers. The connecting nails are corroded and many are rusted completely in two. In many places the attachment hardware utilizes lag bolts screwed into the deck floor joists at an angle parallel to the wood grain (toe-nailed). This can and has split the joists. This hardware too is severely corroded. All of these factors have created a deck system that is sagging, separating from the home, and in danger of imminent failure. The decks should be repaired by a licensed general contractor, if the repair is beyond the scope of the building code a licensed professional engineer should be consulted.

Joists 24" on center

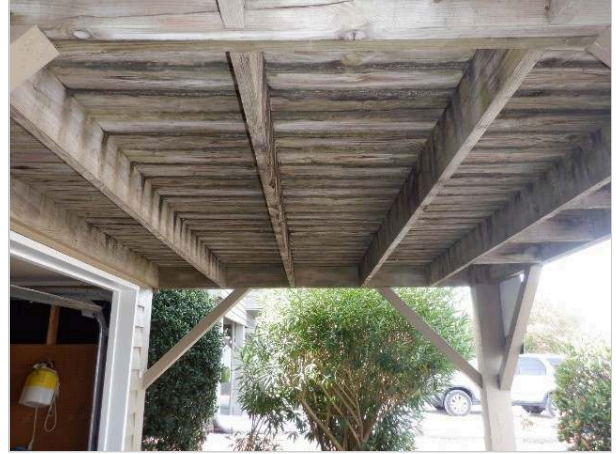
Joists 24" on center

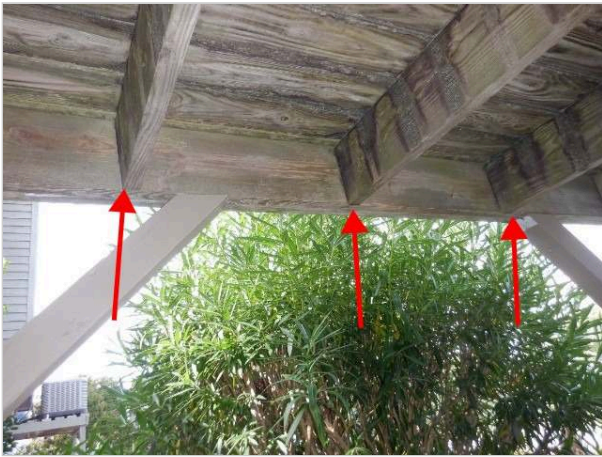
No ledger strip or hanger

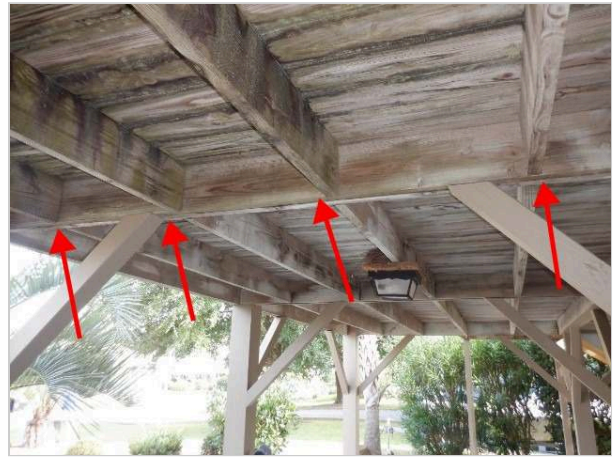
No ledger strip or hanger

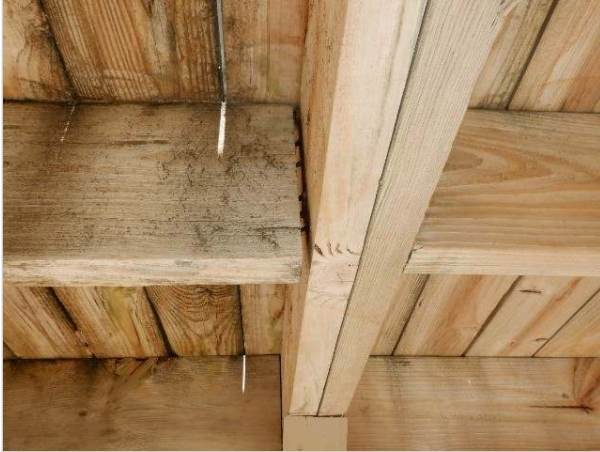
Corroded nails and separation

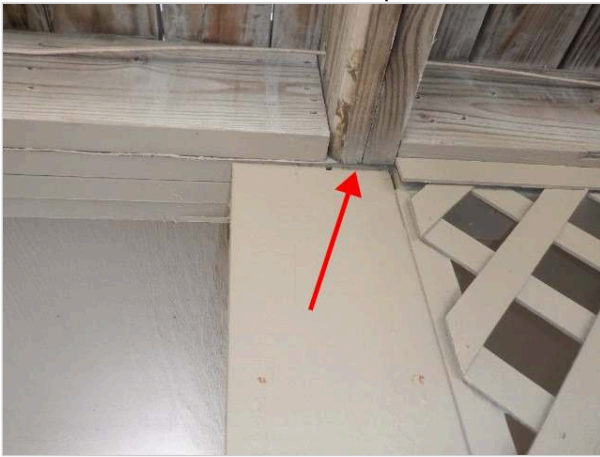
No hanger

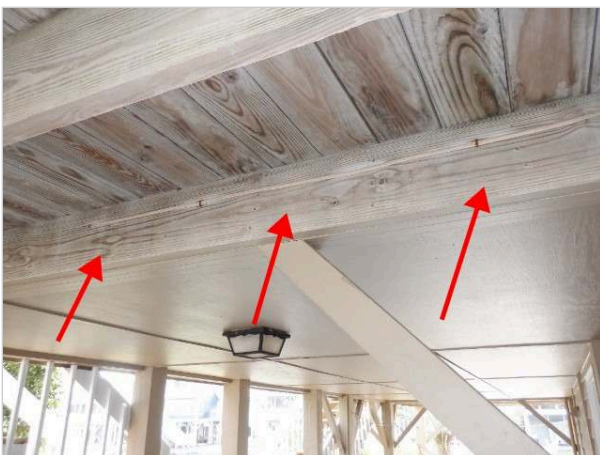
The lower front deck relies on a nailed attachment to the framing of the home for structural support. A supporting attachment that uses only nails presents a safety hazard due to the potential for corrosion that can jeopardize the deck support and cause the deck to collapse. When a deck is supported by attachment to the structure, specific attachment schedules utilizing a combination of hot-dipped galvanized nails and bolts or approved self-drilling screw fasteners are required to ensure stability and safety. The deck should be repaired by a licensed general contractor, if the repair is beyond the scope of the building code a licensed professional engineer should be consulted.

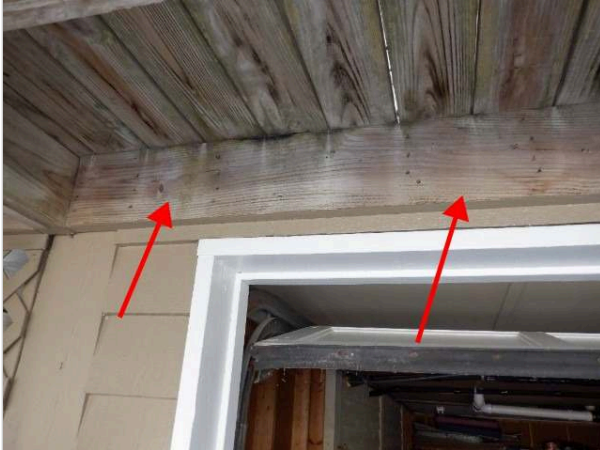
The lower rear deck appears to rely on a lag bolt attachment to the framing of the home for structural support. A supporting attachment that uses only lag bolts presents a safety hazard due to the potential for corrosion that can jeopardize the deck support and cause the deck to collapse. When a deck is supported by attachment to the structure, specific attachment schedules utilizing a combination of hot-dipped galvanized nails and bolts or approved self-drilling screw fasteners are required to ensure stability and safety. Steps have been taken on the rear deck, in the form of lagged blocking, to arrest sagging with debatable results. The deck should be repaired by a licensed general contractor, if the repair is beyond the scope of the building code a licensed professional engineer should be consulted.

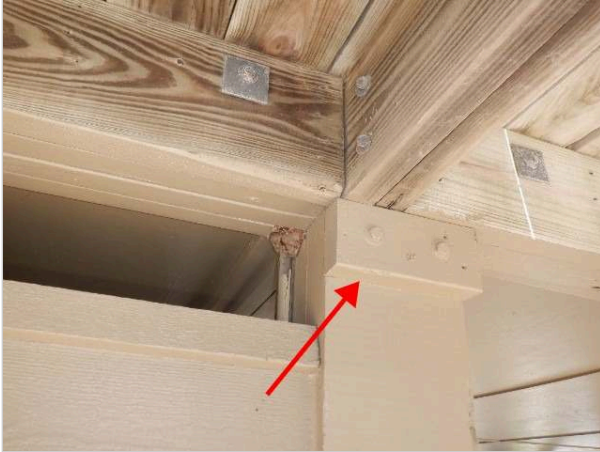
Blocking

At the lower front deck, one of the girder framing members is split. This could allow for further structural movement of the deck and possible failure. The deck should be repaired by a licensed general contractor, if the repair is beyond the scope of the building code a licensed professional engineer should be consulted.

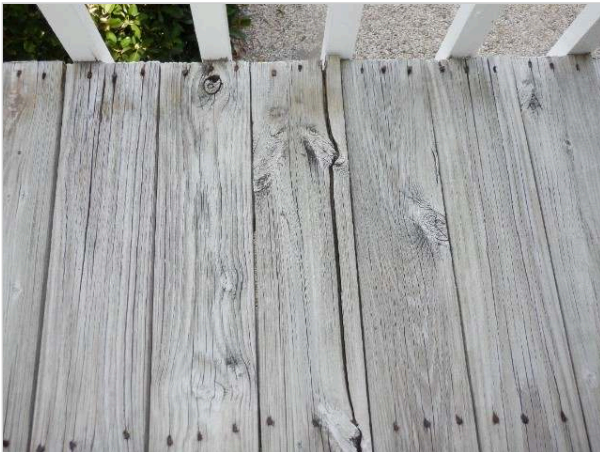
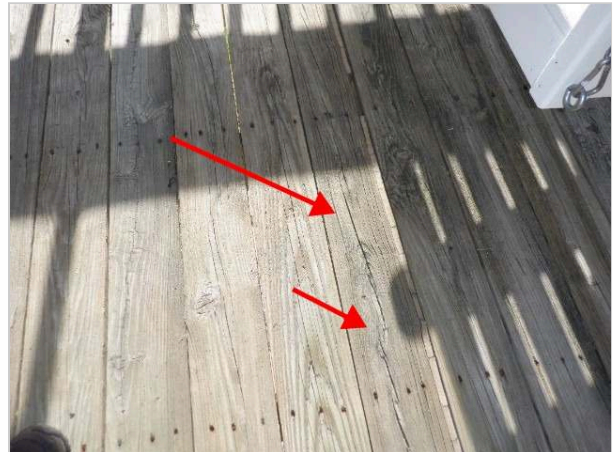
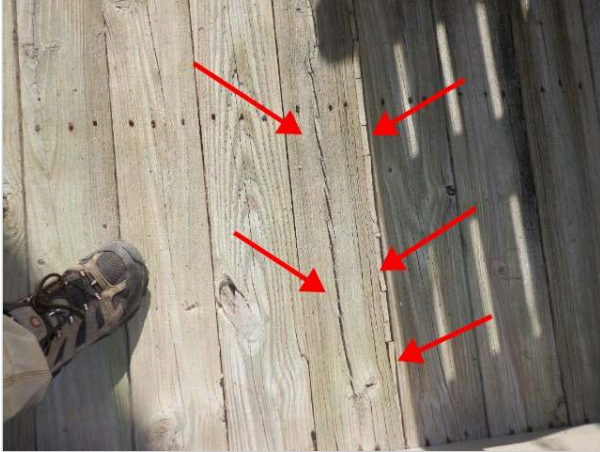
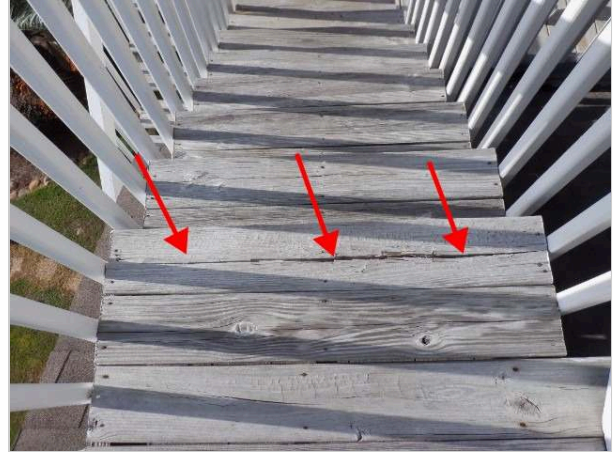
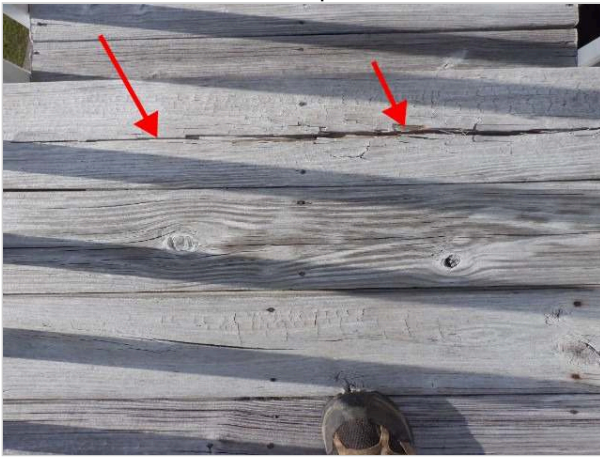
On multiple areas of the decks and steps, there are several water damaged boards. These boards will continue to deteriorate and eventually become unsafe. Have a qualified contractor repair as required.

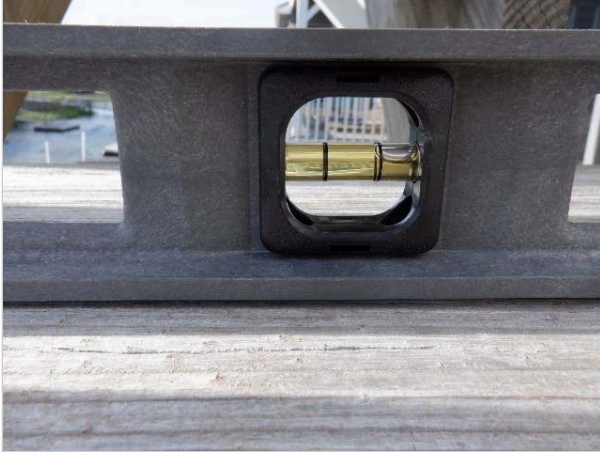
The rear cantilevered steps to the rear middle deck are in poor condition. The stair system is sagging away from the home. Across the width of the steps, the stair system is sagging approximately 2 1/2 inches. If left, this condition will continue to deteriorate and the steps may fail and collapse.

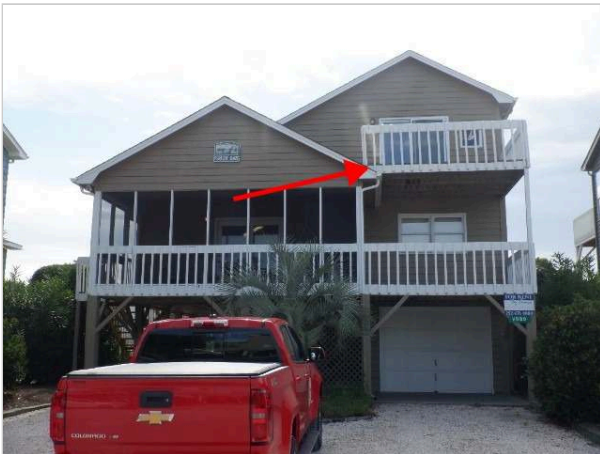
The front upper deck has floor joists that appear to sit directly on top of the lower roof system. These joists do not appear to be attached to the roofing system. Further, as the joists are sitting on the roof shingles, this damages both the shingles and keeps the deck joists wet to the point of deterioration. These conditions could allow for roof leaks and deterioration of the deck joists to the point of structural movement and need of replacement. Have a qualified contractor repair this condition as necessary.

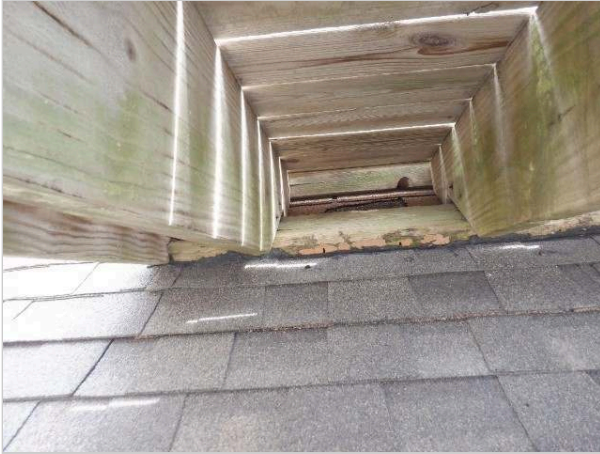
The rear top deck stairs are supported by wood members sitting directly on top of the roof shingles. This condition appears to prevent the roof from draining properly in this area and holds water against the supporting wood member. These conditions could allow for roof leaks and deterioration of the deck support to

the point of structural movement and need of replacement. Have a qualified contractor repair this condition as necessary.

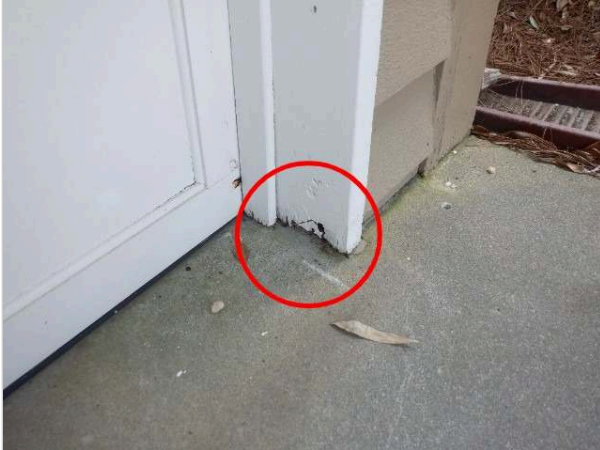
The exterior trim is water damaged in three places (these areas include, but are not limited to areas seen in photos). This is at the right side of the garage door, and at the rear gable end of the roof and at the stain glass window. If left, this will deteriorate further, attract mold and wood destroying organisms and allow moisture to penetrate structural components. Have a qualified contractor evaluate and advise regarding siding, trim, and any affected structural components, then repair as required.

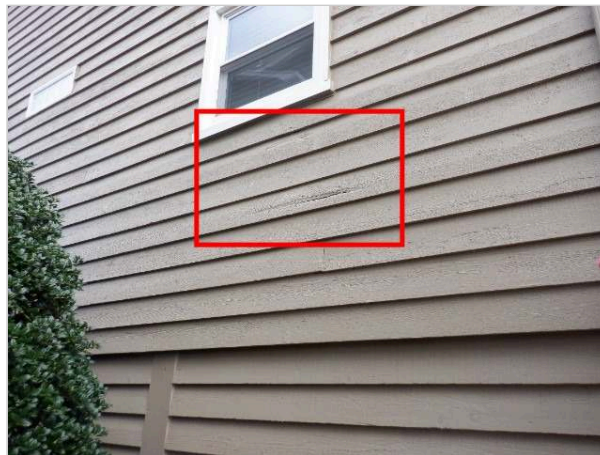
The siding water damaged in one place (these areas include, but are not limited to areas seen in photos). If left, this will deteriorate further, attract mold and wood destroying organisms and allow moisture to penetrate structural components. Have a qualified contractor evaluate and advise regarding siding, trim, and any affected structural components, then repair as required.

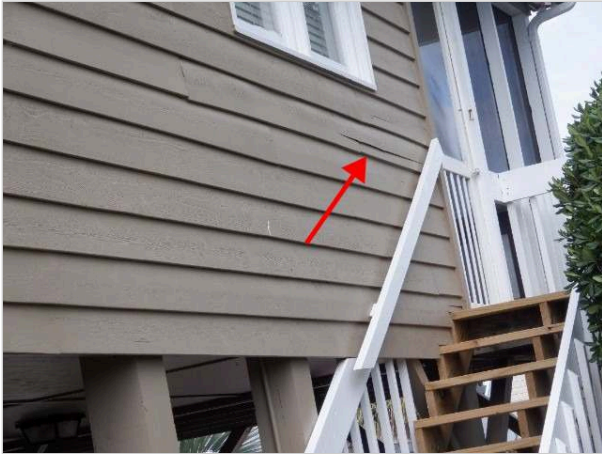
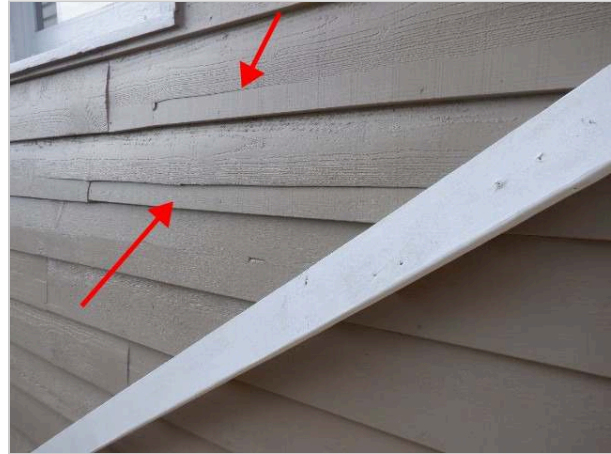
Left side

The wood siding is cracked on the left side and at the front left gable. Moisture can infiltrate these cracks and lead to mold, mildew, and water damaged structural components. Have a qualified contractor seal the cracks.

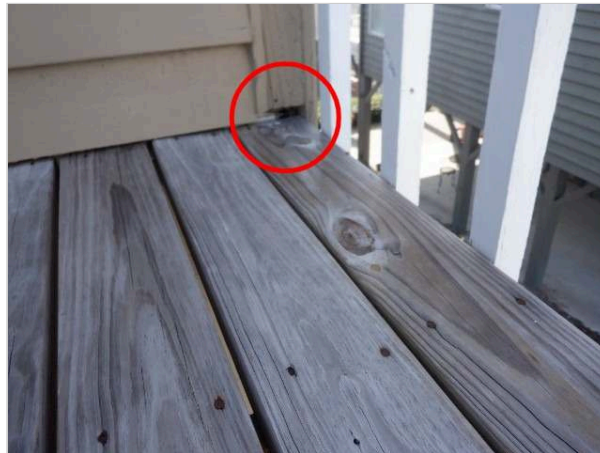
At one place the siding and trim leave a gap where water can infiltrate. This is at the upper front deck below the stain glass window. This can lead to mold and mildew and water damaged siding, trim, or structural components. Have a qualified contractor evaluate all siding and trim, advise, and then repair as required.

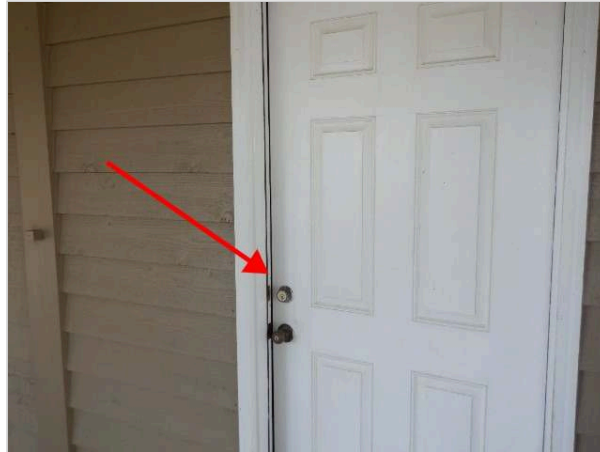
At the storage room door, the door bumps and rubs on the frame. This will accelerate wear on the door, frame, and hardware. Have a qualified contractor evaluate, and repair as required.

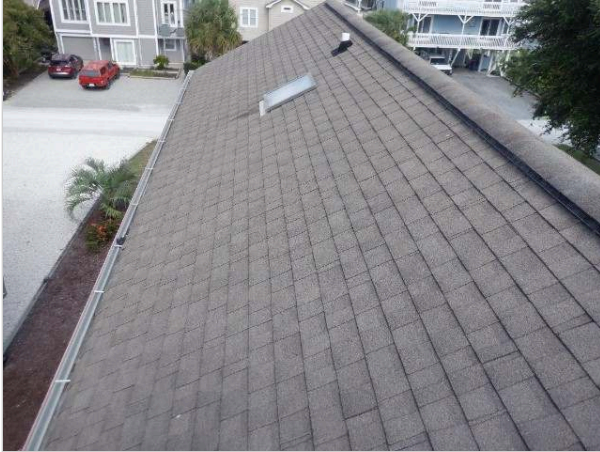
This roof appears to be nearing its useful, reliable lifespan. All of the shingles exhibit wear to the extent of showing the fiberglass substrate at the edges and considerable granule loss. If left, water damage can occur to structural components. Have a qualified contractor to evaluate, advise, and replace.

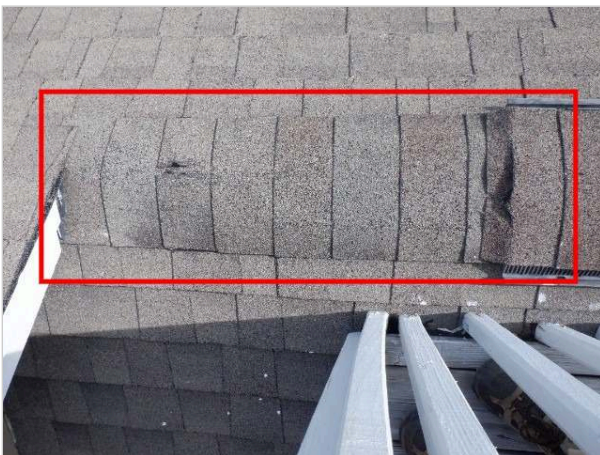
On the peak of the roof, there are several shingles that are cracked or broken. If not repaired, these may allow rain water to blow under the shingles and are more likely to become wind damaged. Have a qualified contractor repair as required.

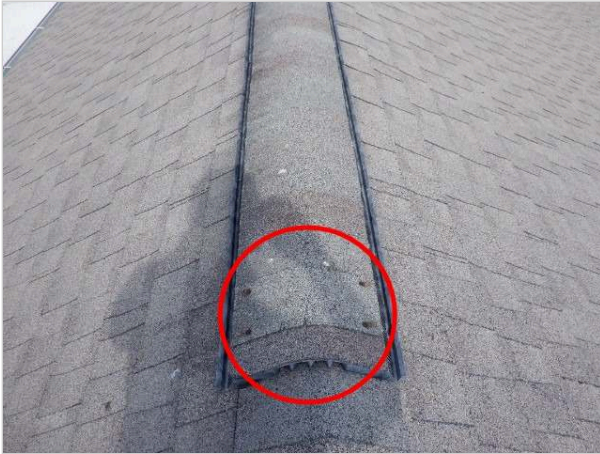
There are nail heads exposed on the shingles at the ridge vent. This can allow moisture to penetrate around the nail heads and damage the roof sheathing. Have a qualified roofing contractor seal the nails as required.

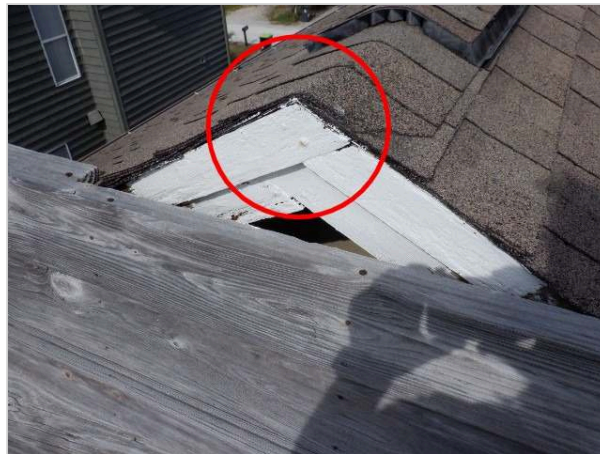
On the roof, at the rear, the shingles have insufficient overlap at the edge. This can allow windblown rain to penetrate and damage structural components. Have a qualified roofing contractor repair as required.

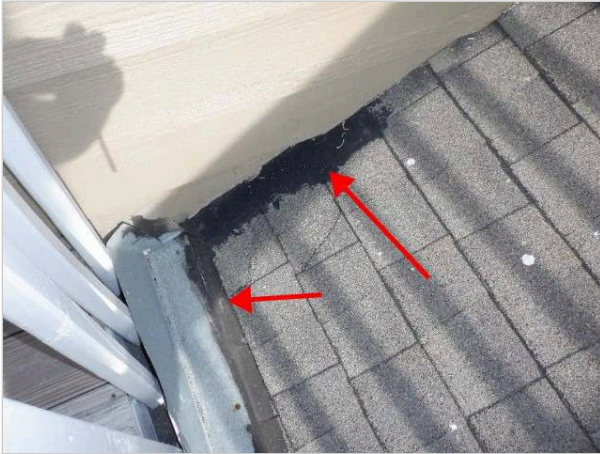
The flashing on the roof adjacent to the rear mid-level deck is not properly installed and is pulling away from the shingles and sealant. This can allow wind-blown rain to penetrate damaging interior and structural components. Have a qualified contractor repair the flashing.

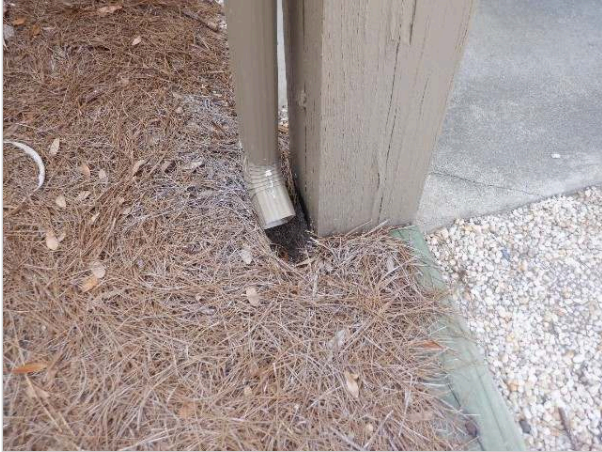
There were four downspouts draining at or too close to the foundation. If not moved away from the structure properly, this water can adversely affect the foundation and wood pilings. Have a qualified contractor correct this condition as required.

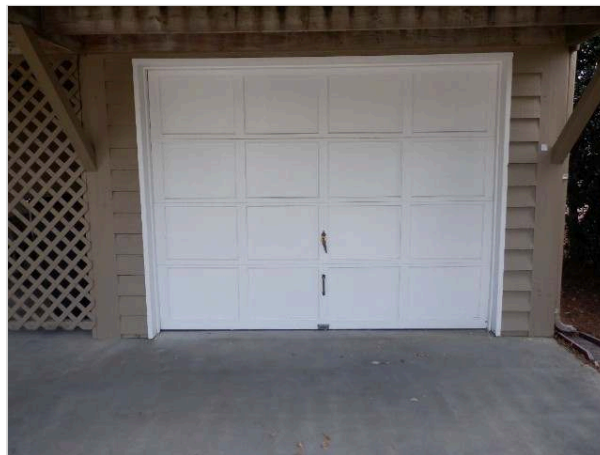
At the garage roll-up door(s), there is missing weather stripping. This could allow rain to blow into the garage

or provide access for pests. Have a qualified contractor install weather stripping on this door.

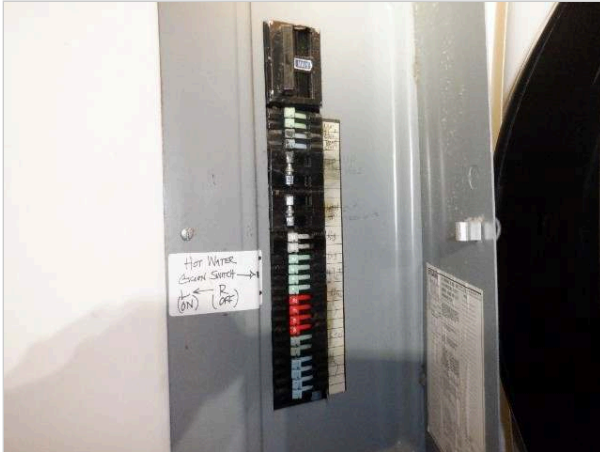
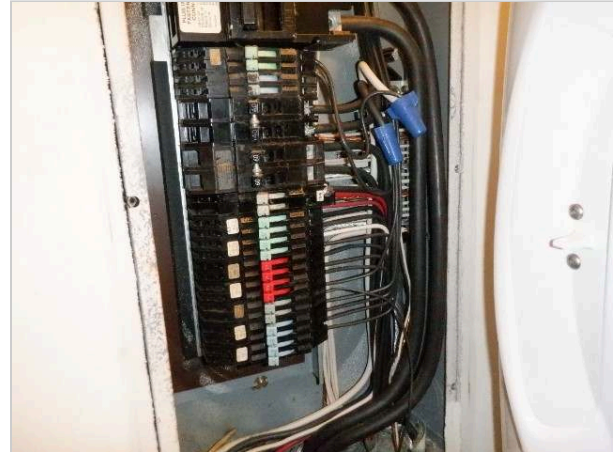
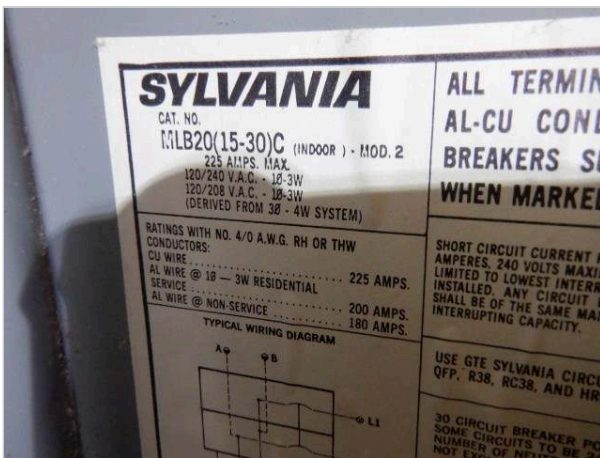
Electric main panel

The electrical system of this home contains a what appears to be a re-branded Zinsco service panel and or a service panel with Zinsco components. Although Zinsco panels and components were innovative at the time of inception, the reliability and safety of the panel has been in question due to documented circuit breaker and busbar failures. These panels have been associated with overheating, failure to trip, fires, and other defects. A licensed electrical contractor should be consulted for a complete invasive inspection of the electrical panel to determine if repair, modification, or replacement is needed to ensure safe and reliable service.

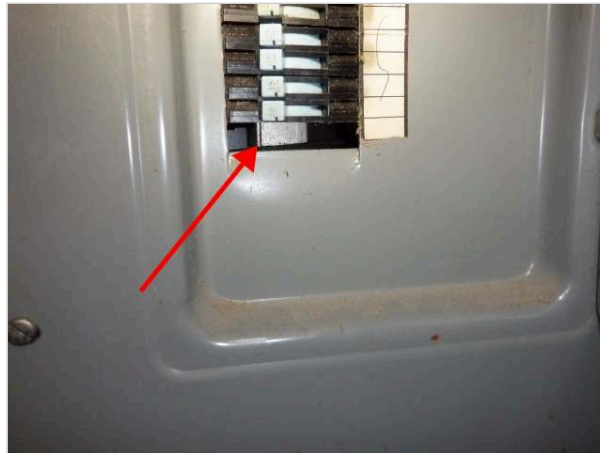
In the main electrical panel, there is one open slot where the breaker knockout is removed. This leaves open areas to live circuits. Have a qualified electrical contractor install knockout covers as required.

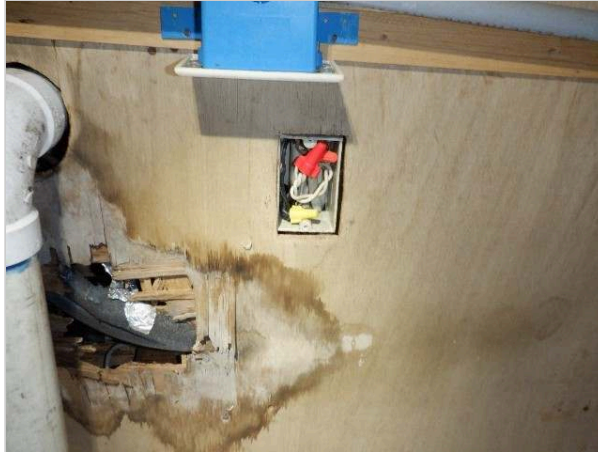
In the storage room, there is an open junction box. This condition presents a safety hazard. Have a qualified electrical contractor repair as required.

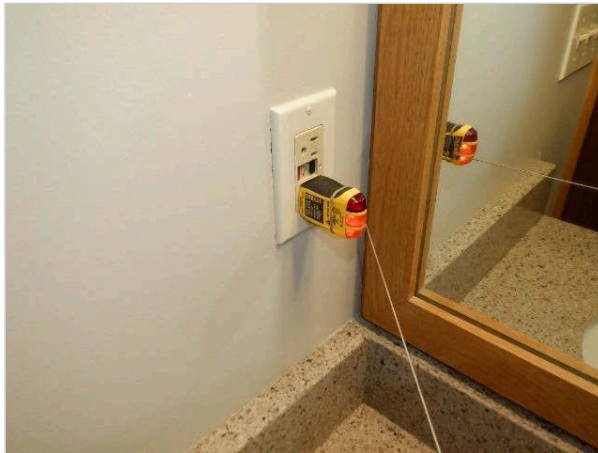
A ground-fault circuit interrupter (GFCI) outlet located downstairs hallway bathroom is defective. The device trips manually but not with the tester would not reset once tested. A defective GFCI outlet can be a safety hazard. Have a qualified electrical contractor replace the GFCI outlet and confirm safe operation.

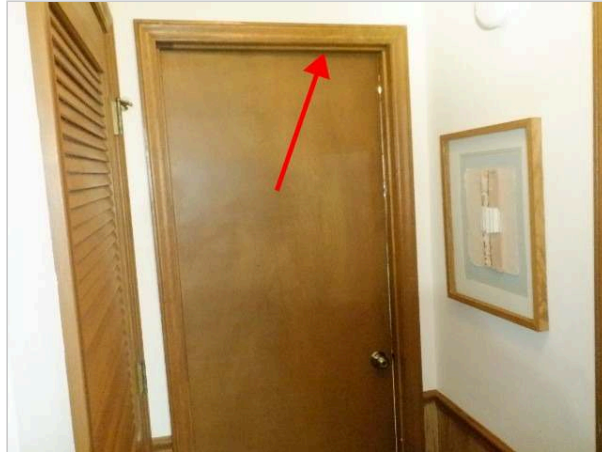
At the downstairs front bedroom door, the door bumps and rubs on the frame. This will accelerate wear on the door, frame, and hardware. Have a qualified contractor evaluate, and repair as required.

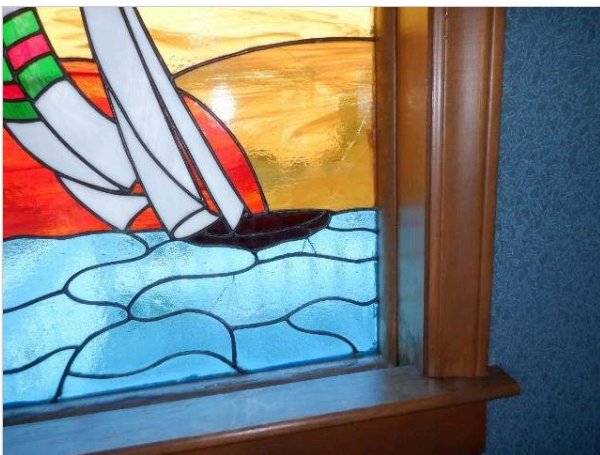
Cracked glass was noted on the stained glass window. For safety and security all cracked and broken glass should be replaced. Have a qualified contractor repair or replace the window as required.

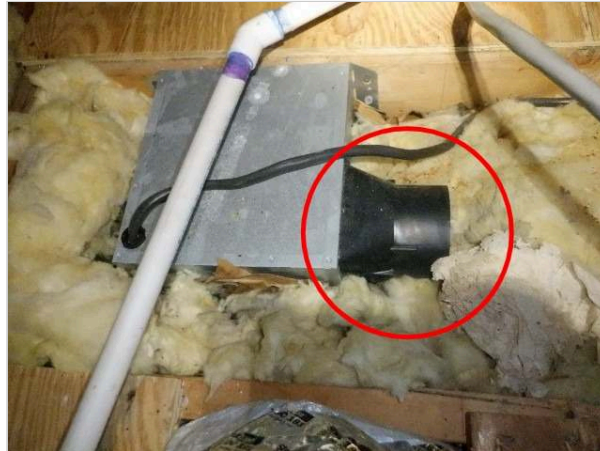
One bathroom vent fan exhaust tube is defective in the attic. This open tube can introduce excessive condensation into the attic space causing mold, wood rot, and attracting wood destroying organisms. Have a qualified contractor repair as required.

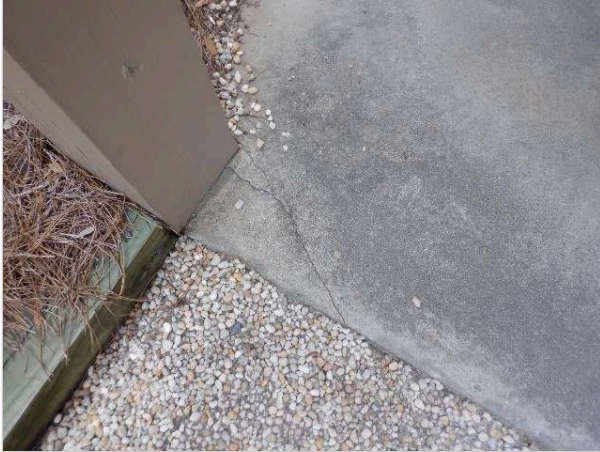
The parking pad/ slab has cracked and settled unevenly. These conditions may deteriorate further especially in freezing conditions, in the presence of moisture, and can be a tripping hazard. Have a qualified contractor evaluate and repair as required.

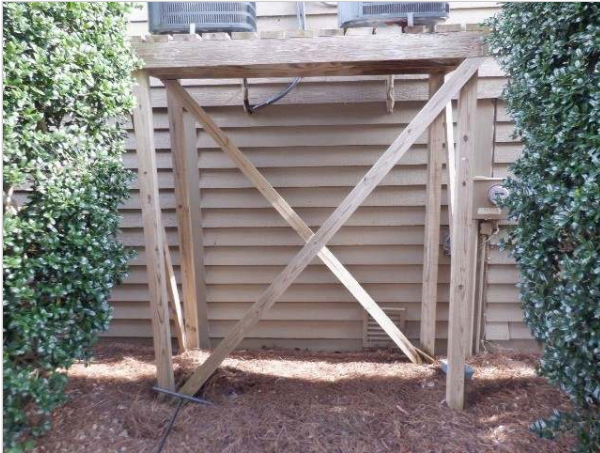
On the right side of the home, at the HVAC unit(s) platform, the platform posts are rotted at ground level. This has affected the platform's structural integrity and the assembly is rocking from side to side - in danger of collapse. Have a qualified contractor repair this platform as necessary.

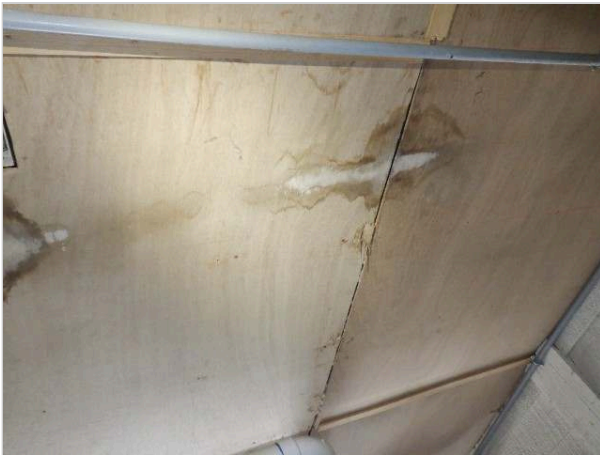
In the garage area, the ceiling is water stained and damaged due, apparently, to the condensation forming on the HVAC line sets that pass through the garage ceiling. If left, this can continue to deteriorate structural components of the ceiling/floor system. Have a qualified HVAC contractor repair this condition as necessary. Have a qualified contractor repair any structural components as necessary.

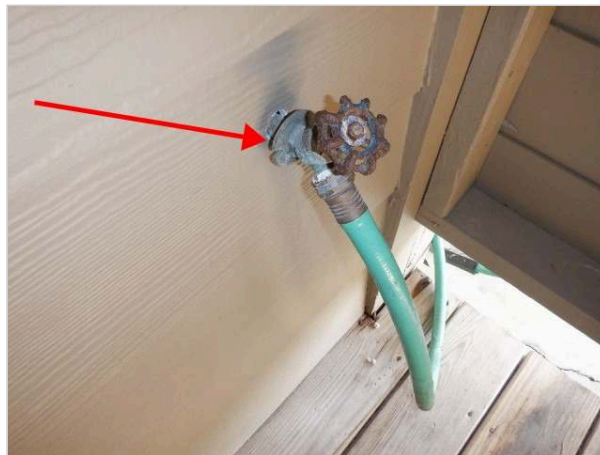
The rear outdoor faucet bonnet flange is loose from the house. A loose faucet may eventually break and leak large quantities of water. Have a qualified plumbing contractor reattach the bonnet flange to the structure.

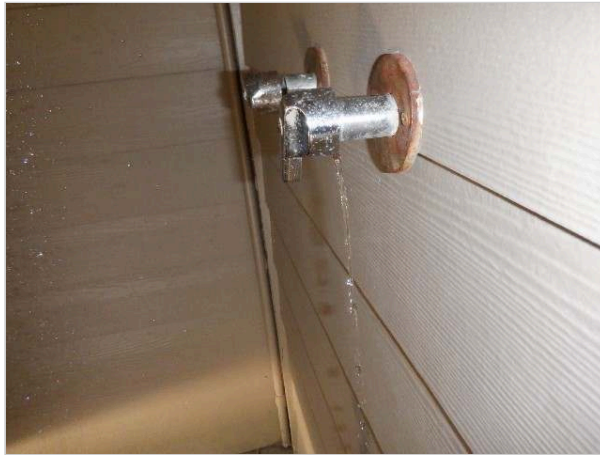
The outside shower faucet leaks at the hot water valve stem. If left, this condition will deteriorate further and

the fixture may fail. Have a qualified plumbing contractor repair as required.

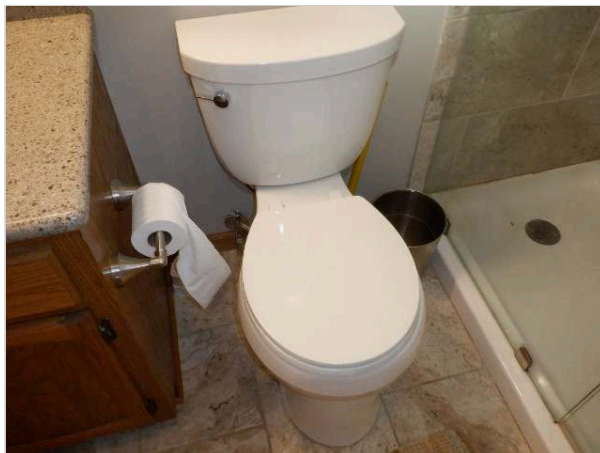
The downstairs hallway bathroom toilet is loose on its mounts. If left, this condition will deteriorate further and the fixture may leak. Have a qualified plumbing contractor repair as required.

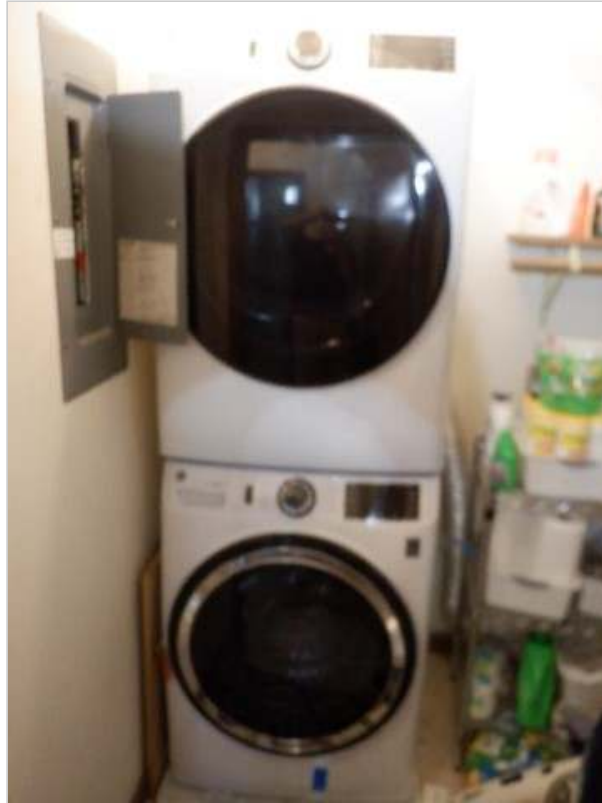
In the storage room, the dryer vent pipe is the flexible ribbed type. This material will catch lint and clog easily. A clogged dryer vent is a fire safety hazard. Have a qualified contractor install 4" galvanized pipe in straight runs with minimal turns.

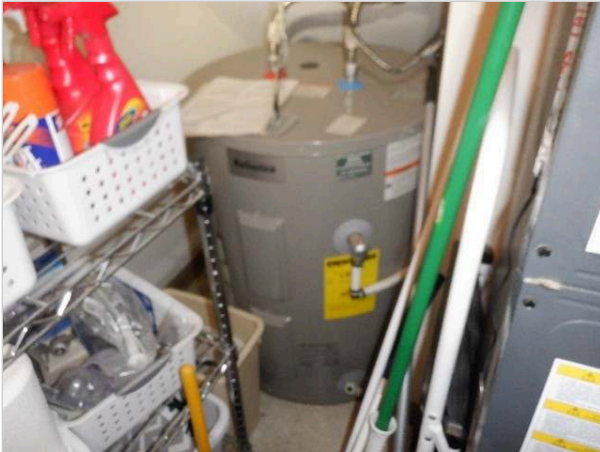
This water heater is sitting directly on the floor with no drip pan. In the event of minor leaks a drip pan can protect floors and other structural components and finishes. Recommend having a qualified plumbing contractor install a drip pan here.

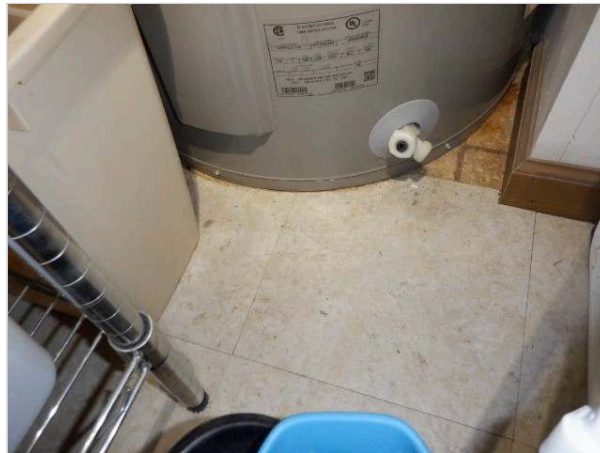
In this home, there was no expansion tank installed in the water supply system. The purpose of an expansion tank is to accommodate thermal expansion of water as it heats up in the water heater. If water pressure gets high enough it can damage valves in plumbing fixtures, joints in supply pipes and even the water heater. Have a qualified plumbing contractor install an expansion tank.
